the **play inspection** company

Annual Inspection

Torpoint Town Council

Thanckes Park Play Park

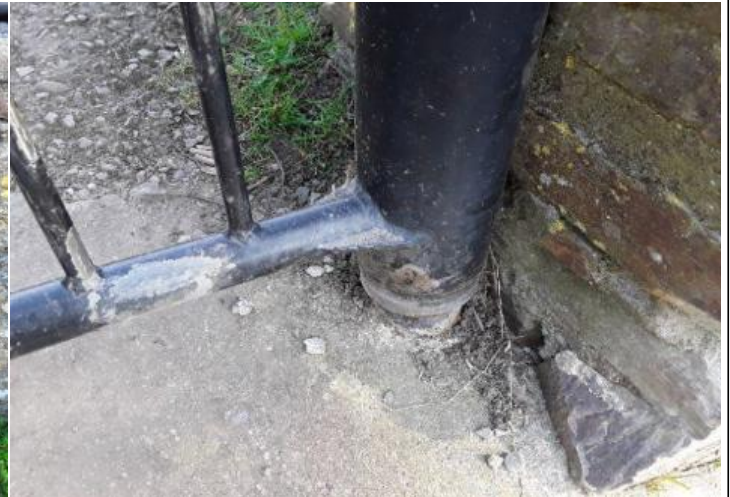
Finding: There is or are fixings missing on the item

Action: Replace all missing fixings

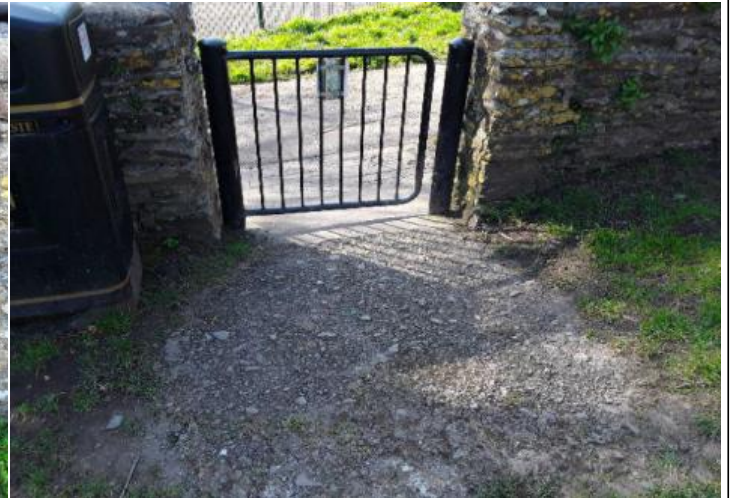
Finding: The entrance is becoming uneven

Action: Monitor for any further deterioration or creation of trip points and repair as required

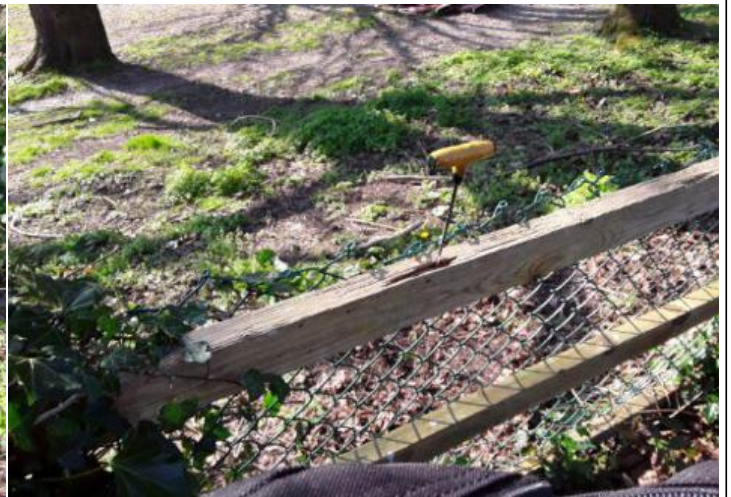
Finding: There is some evidence of rot in the timber

Action: Monitor for any further deterioration and replace as required

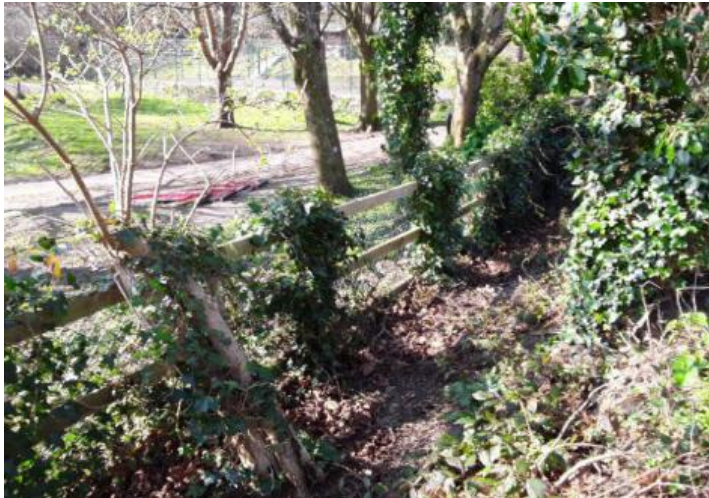
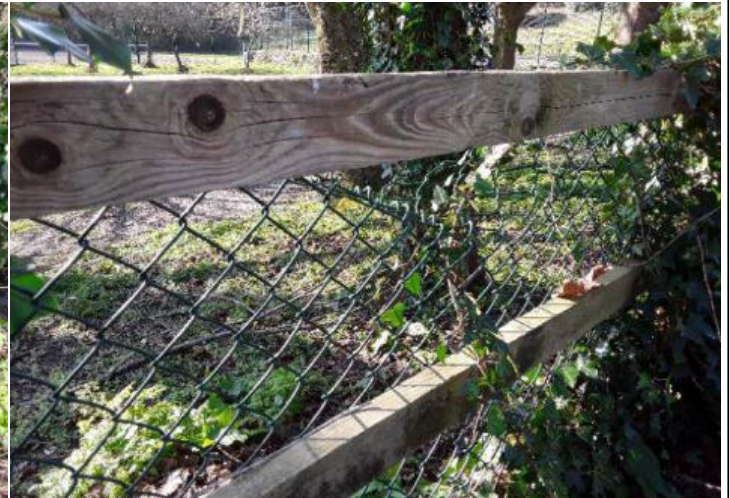
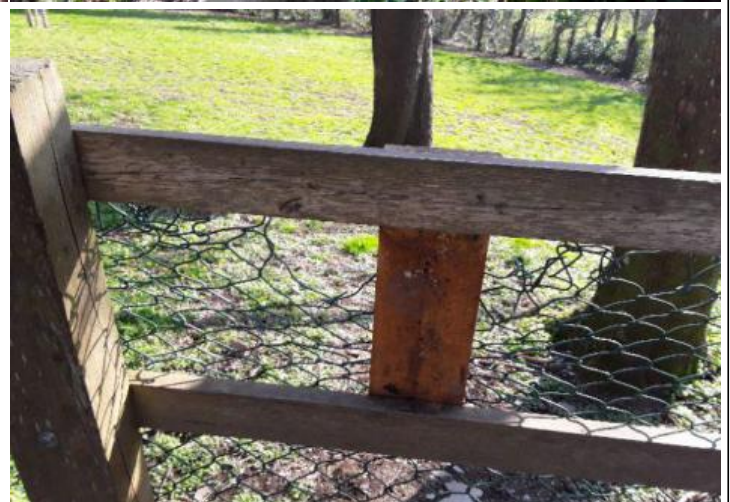
Finding: There is some damage to the fence sections

Action: Monitor for any further deterioration and repair as required

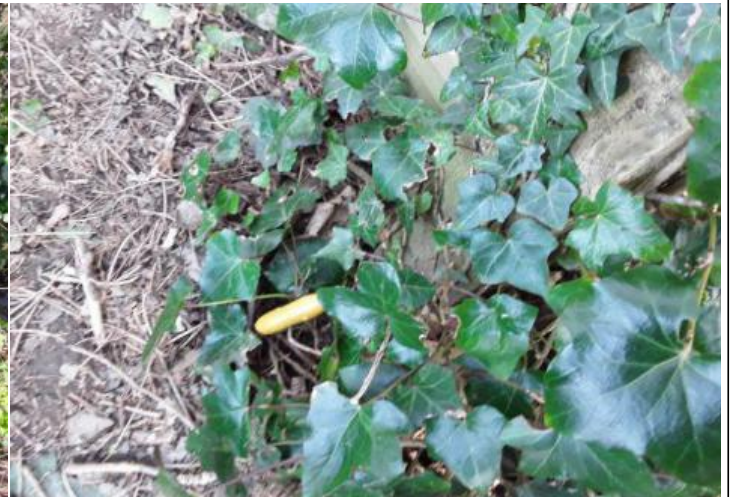
Finding: There is some evidence of rot in the timber posts
Action: Monitor for any further deterioration and replace as required

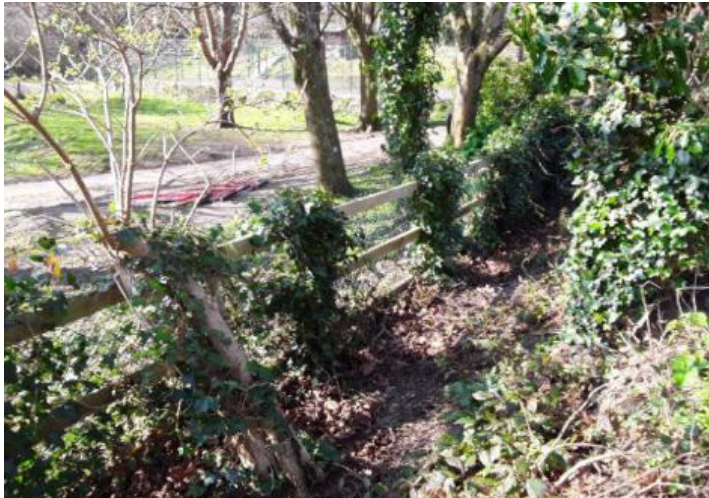
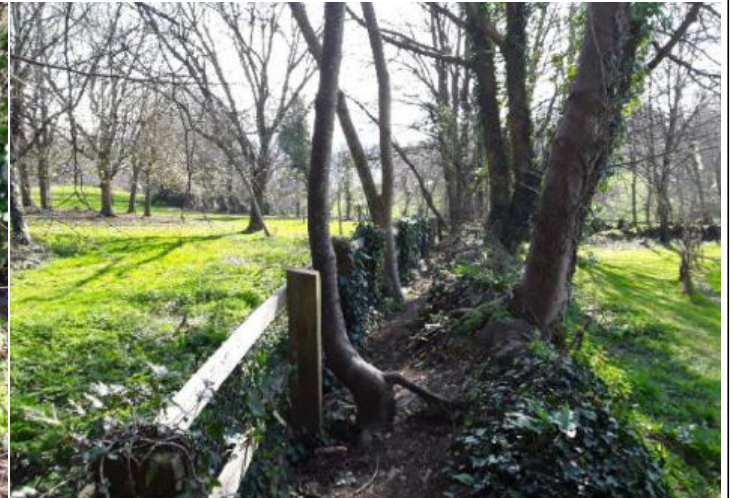
Finding: There are a number of loose posts around the fence

Action: Monitor for any further deterioration and reset as required

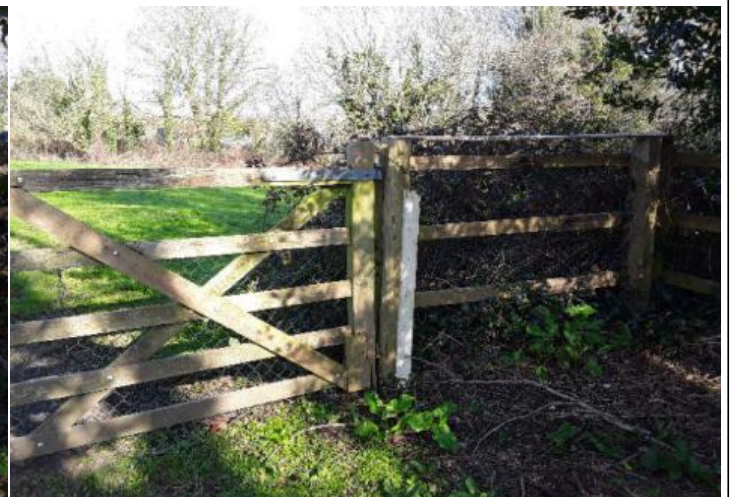
Finding: The gate post has rotted and sheared and is unstable, the additional support posts installed are inadequate to support the structure.

Action: Replace all affected timbers

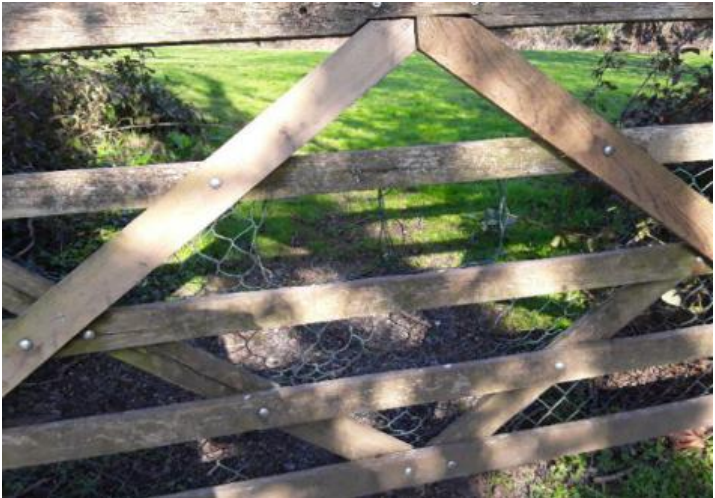
Finding: The item has been damaged

Action: Monitor for any further deterioration and replace as required

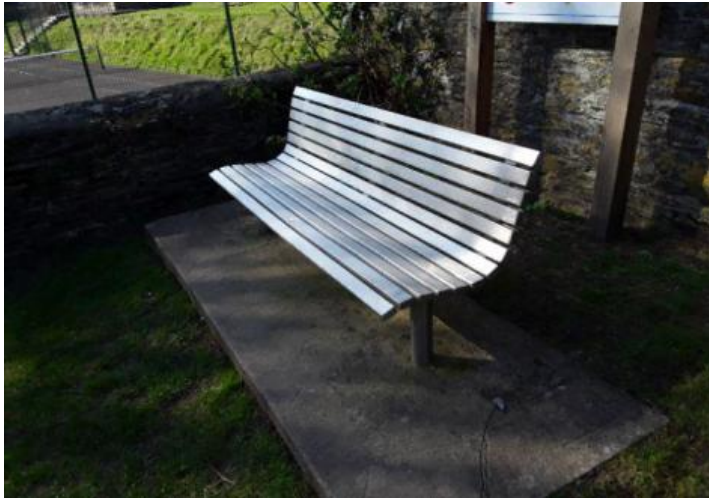
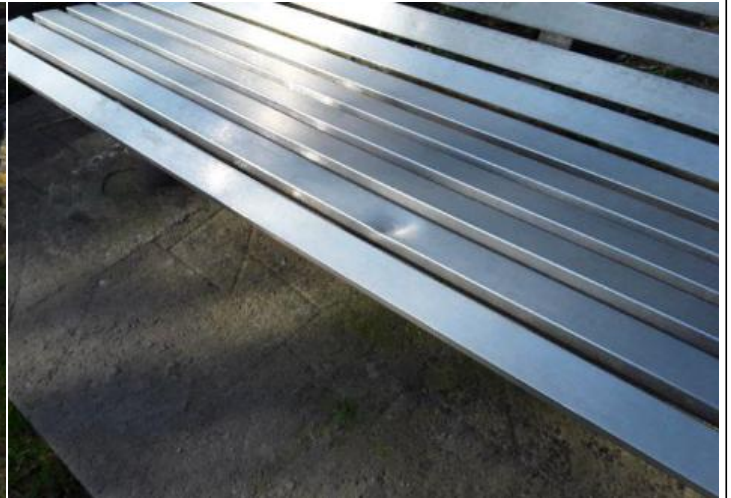
Finding: The item has been damaged

Action: Monitor for any further deterioration and replace as required

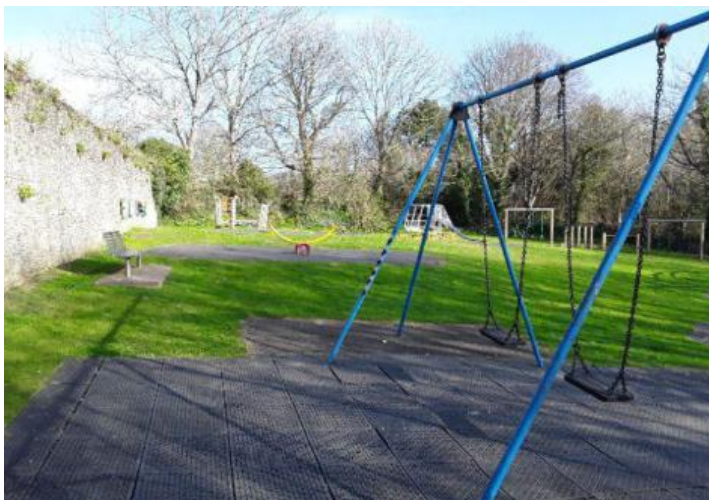
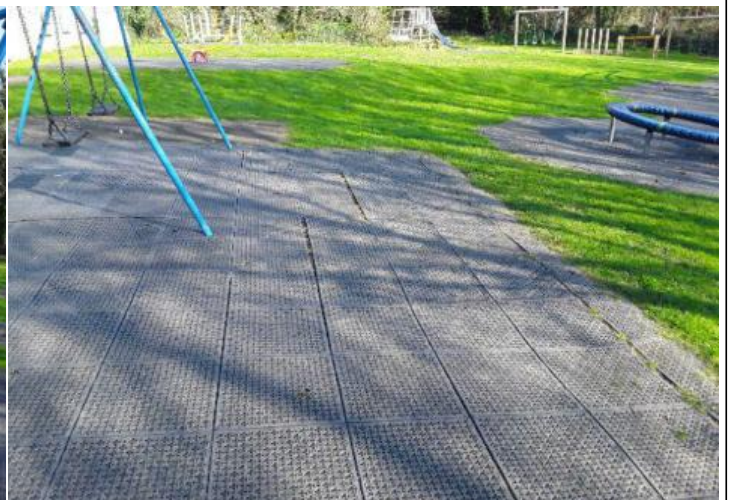
Finding: Some of the mats throughout the site have separated, are loose and can be lifted creating trip points

Action: Reinstate surfaces as required

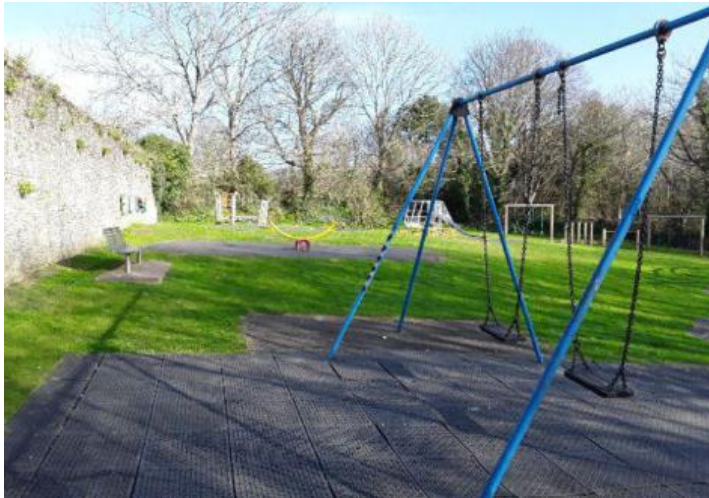
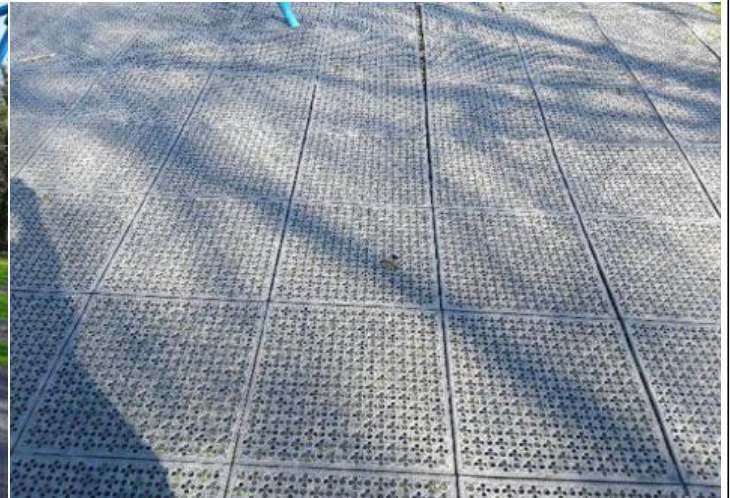
Finding: The safety surfaces around the site have been damaged/are wearing

Action: Monitor for any further deterioration and repair as required

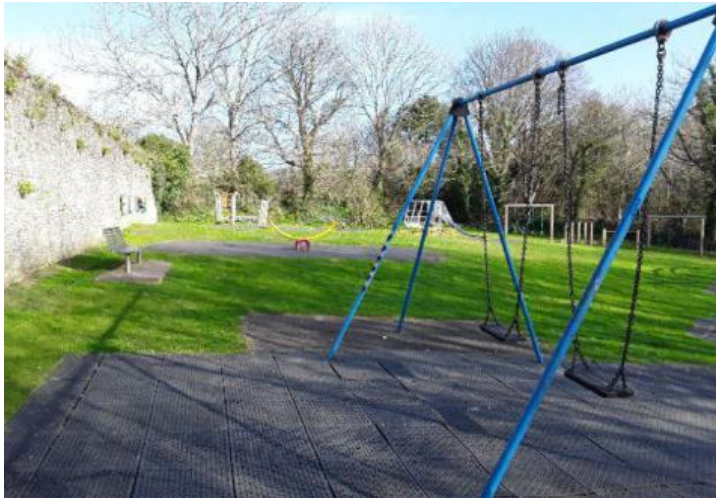
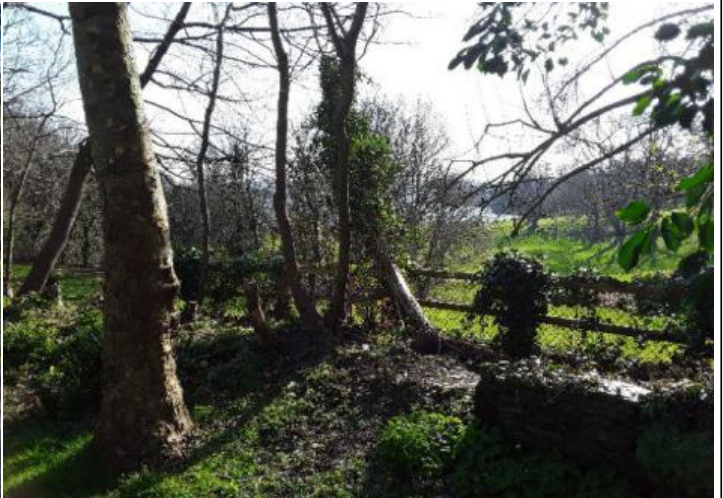
Finding: A significant section of a tree present on site has fallen. The remaining tree trunk is still upright but may be unstable or in poor health.

Action: Ensure that the tree is inspected by a competent person to ensure ongoing structural integrity. We would recommend that the other trees present on site are also inspected. Remove the fallen section of tree.

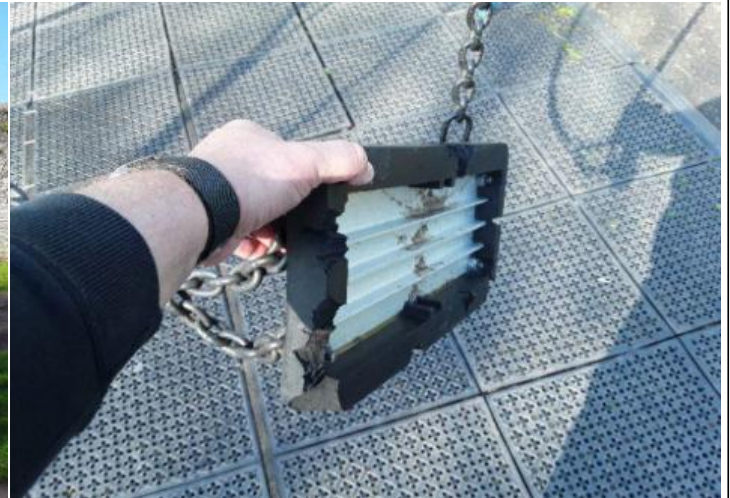
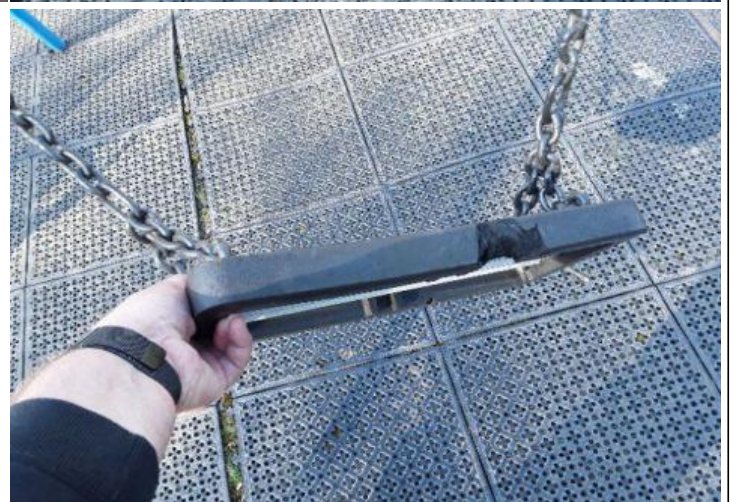
Finding: The seat has minor damage or wear

Action: Monitor for any further deterioration and replace as required

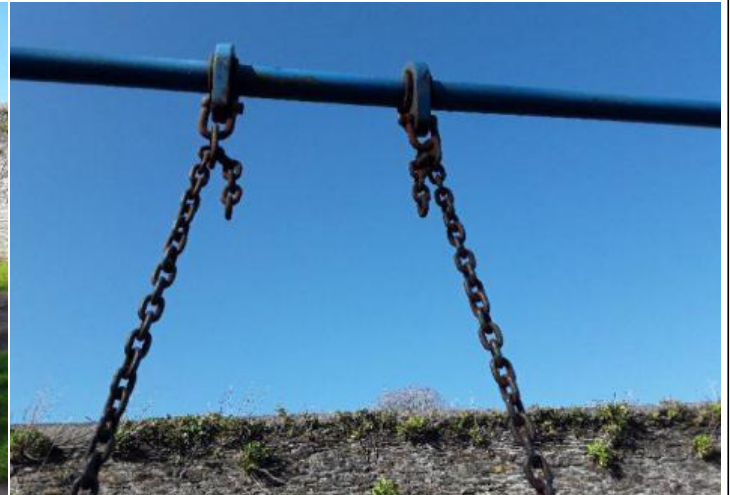
Finding: The bushes are showing signs of wear

Action: Monitor for any further deterioration and replace as required

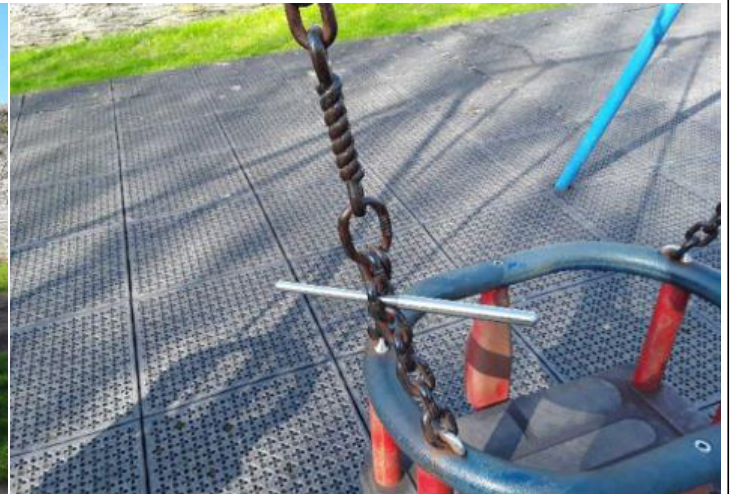
Finding: The connecting links are in excess of 8.6mm and less than 12mm and fail the requirements of BS EN 1176 Part 1; clause 4.2.13, Chains

Action: Monitor - No remedial work recommended

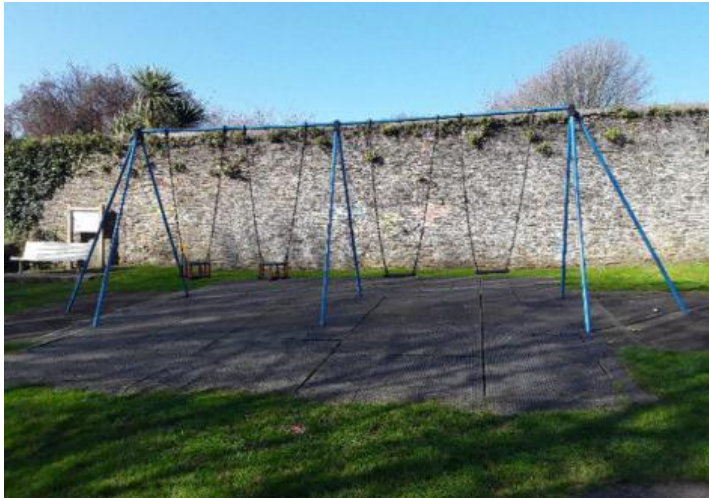
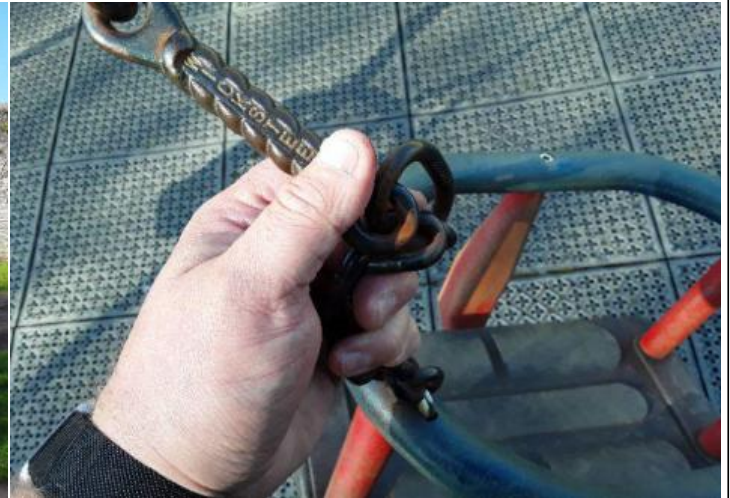
Finding: The chain links are worn in excess of 40% and require renewing

Action: Replace worn chains

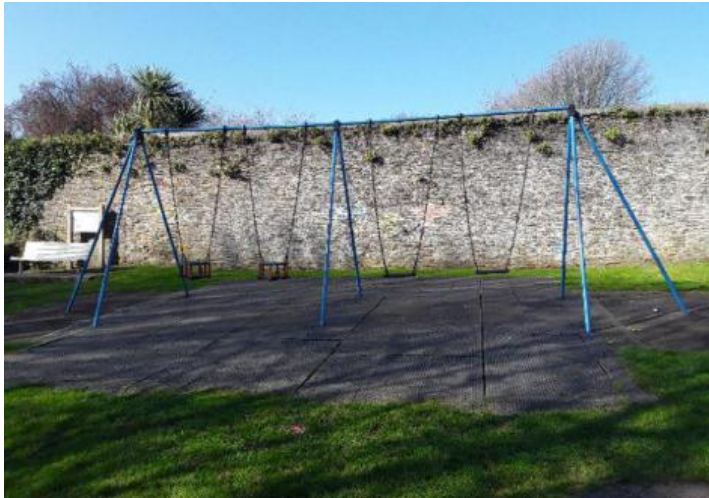
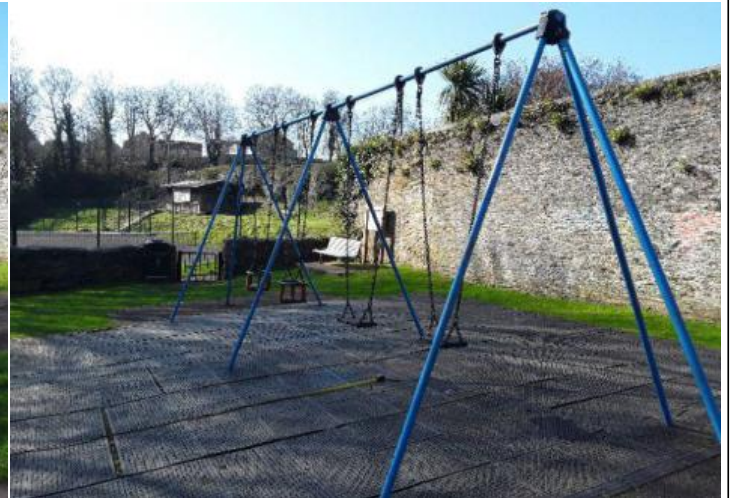
Finding: The fixings or components for this item were in excess of 2.5m above the standing surface and could not be fully accessed by the inspector. We have completed a visual inspection of the fixings from ground level but a maintenance inspection should be undertaken to assess the condition, security and wear of the components at intervals in accordance with the manufacturers recommendations.

Action: Inspect in accordance with the manufacturers recommendations

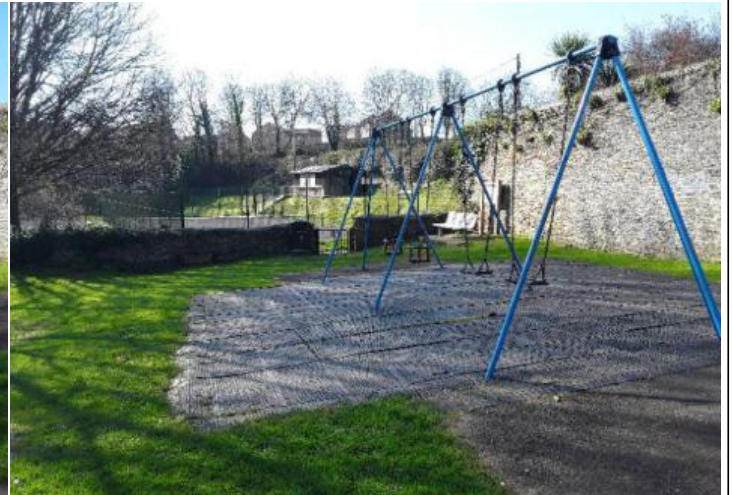
Finding: The surfacing dimensions are short and do not meet with the requirements of the current applicable standard

Action: Monitor - no remedial action recommended

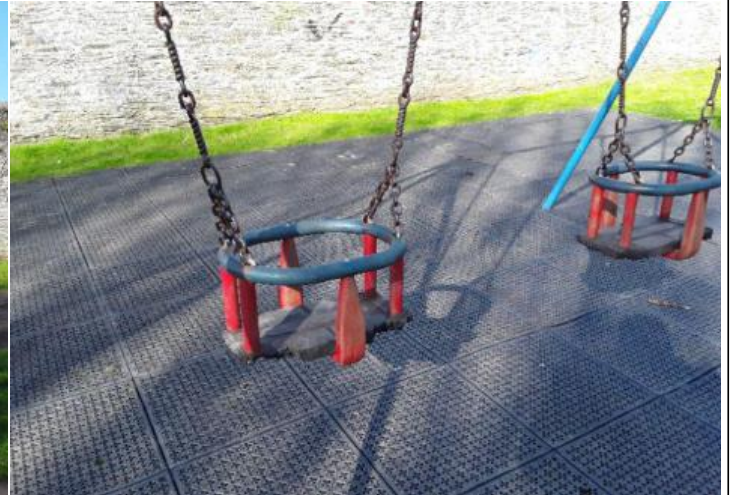
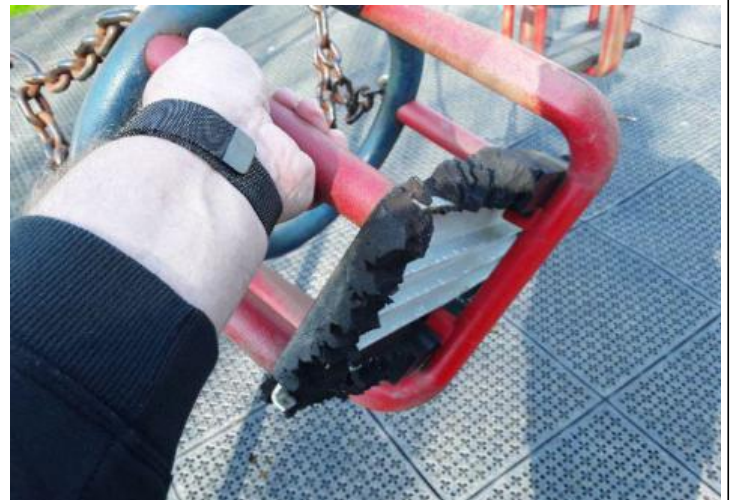
Finding: The seat is severely damaged and requires replacing

Action: Replace damaged seat

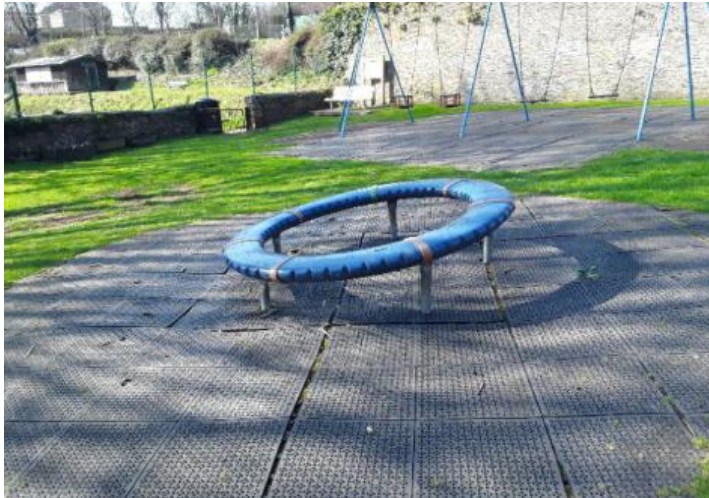
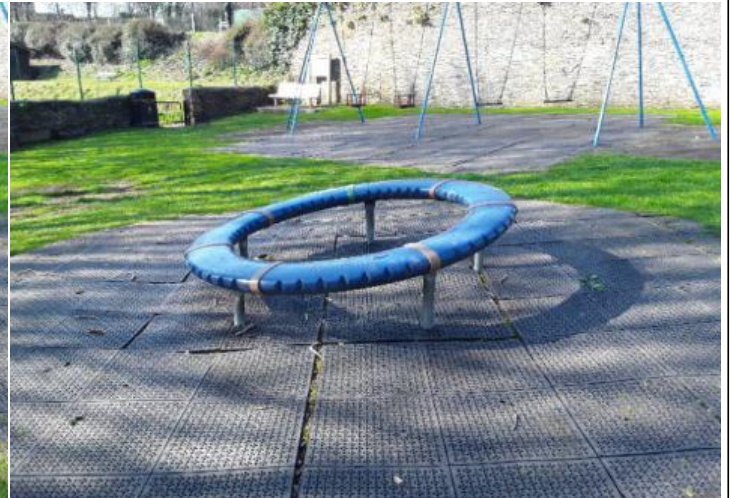
Finding: The surfacing is very loose beneath this unit creating trip points

Action: Repair as required to secure

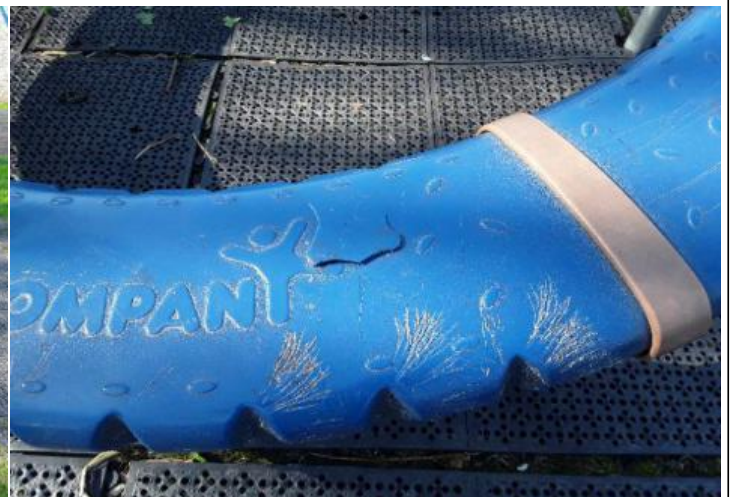
Finding: The casing is cracked in a number of places and rough edges are exposed in two areas

Action: Repair as required

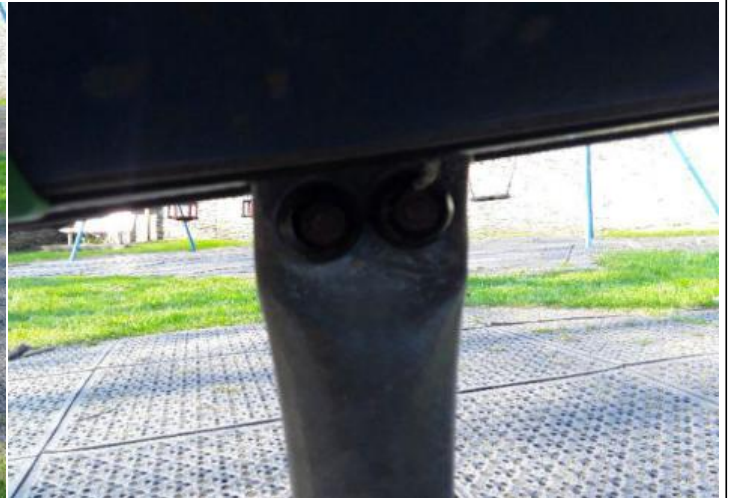
Finding: There is/are bolt cap covers missing or damaged on the item

Action: Replace missing or damaged bolt cap covers

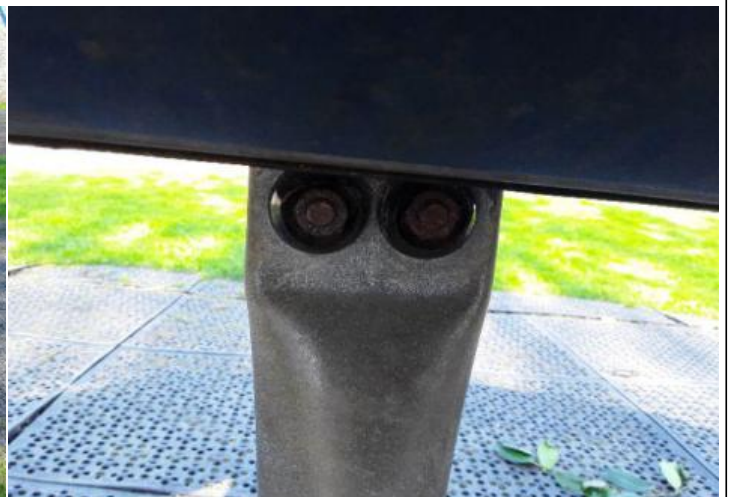
Finding: The fixings have corroded excessively

Action: Replace all corroded fixings

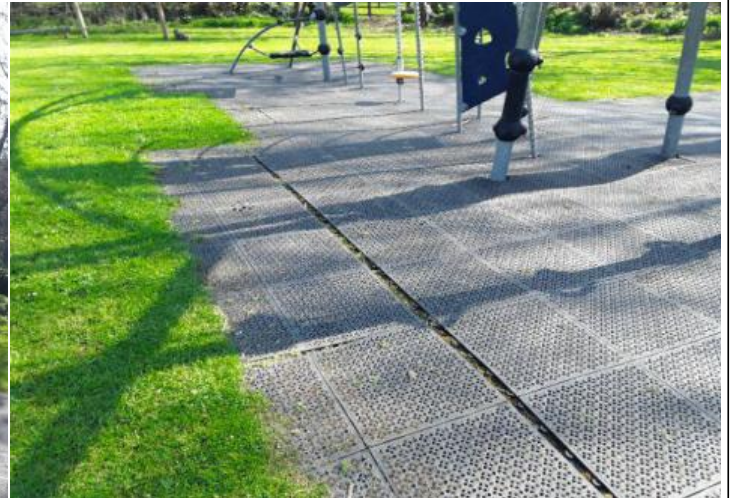
Finding: There are significant gaps (over 30mm) between the surface and the edging or between the joints in the surface; these are large enough for a small foot to enter

Action: Repair surfacing

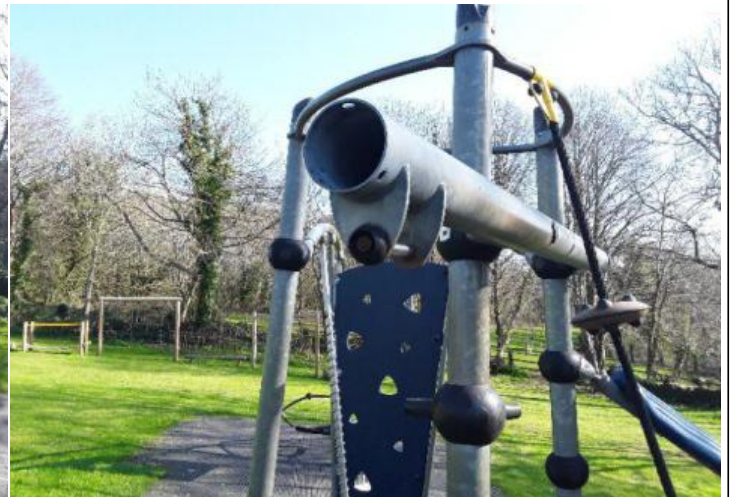
Finding: There are post / end caps missing from the item

Action: Replace missing post caps

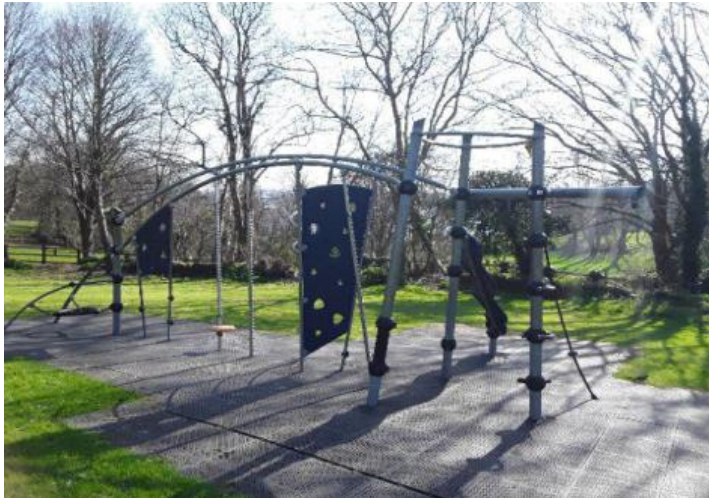
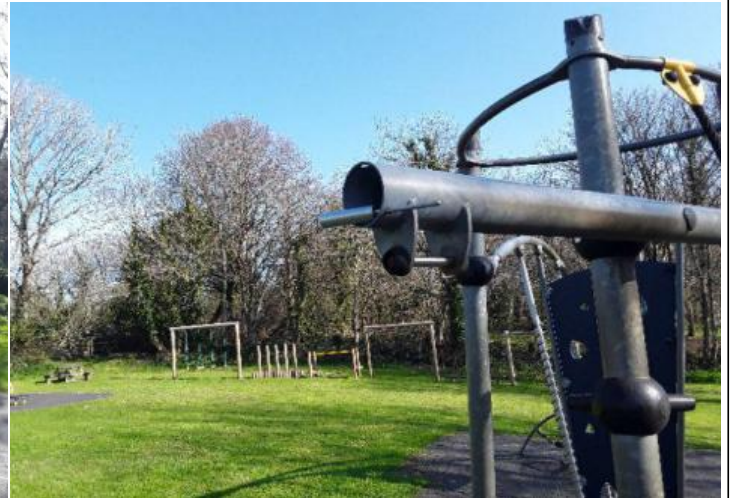
Finding: There is/are finger entrapment/s in the frame due to missing inserts or fixings and the item fails to meet the requirements of BS EN 1176 Part 1 4.2.7.6 Entrapment of fingers

Action: Replace the missing inserts or fixings to remove the entrapment

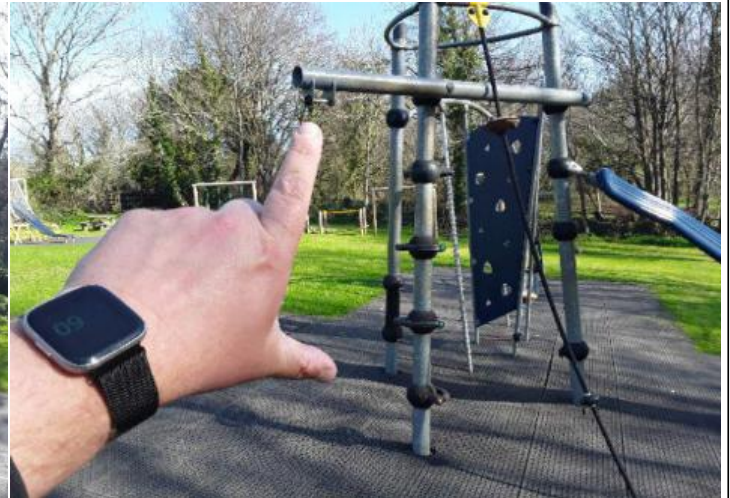
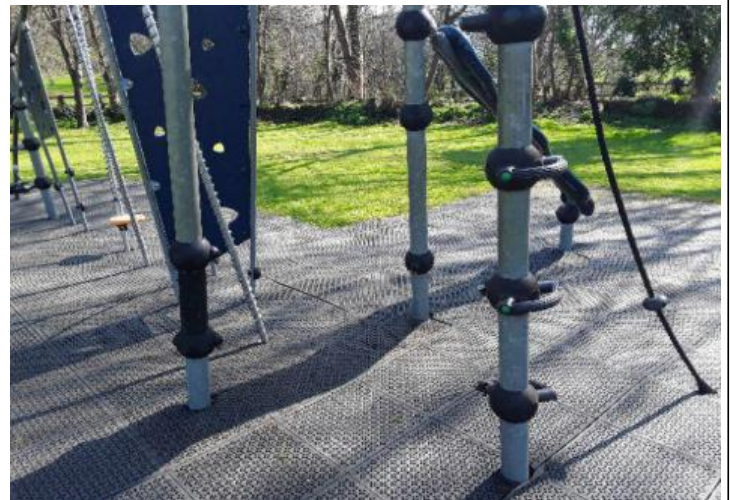
Finding: The multiple has missing component(s) on the structure

Action: Consider replacing missing components

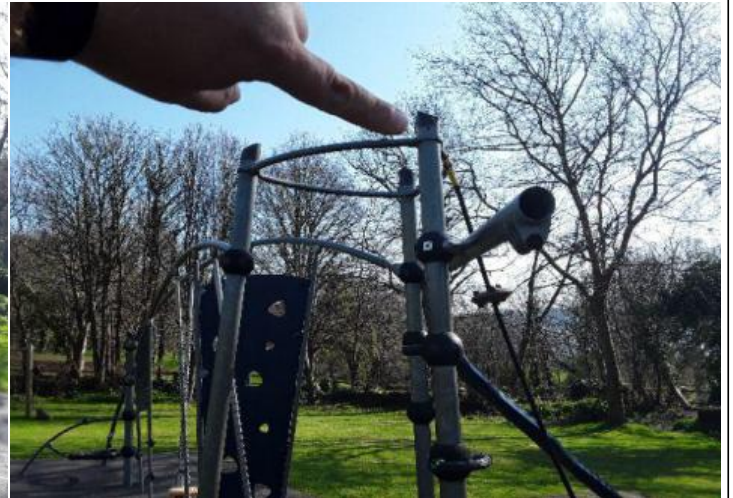
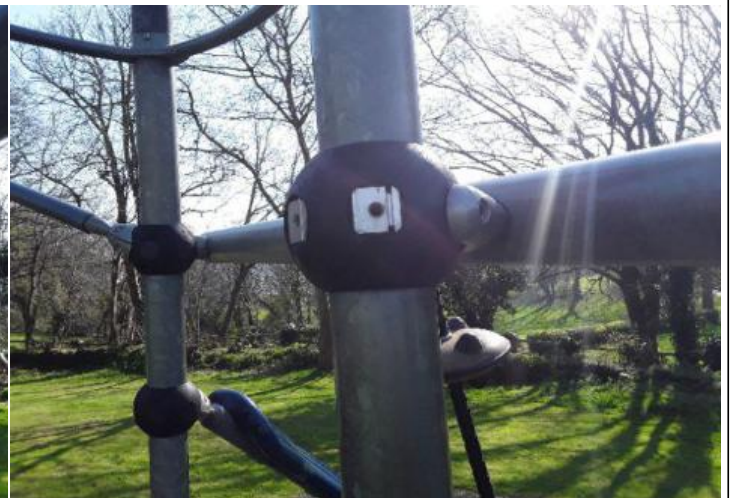
Finding: There is/are finger entrapment/s in the frame due to missing fixings and inserts and the item fails to meet the requirements of BS EN 1176 Part 1 4.2.7.6 Entrapment of fingers

Action: Replace the missing inserts or fixings to remove the entrapment

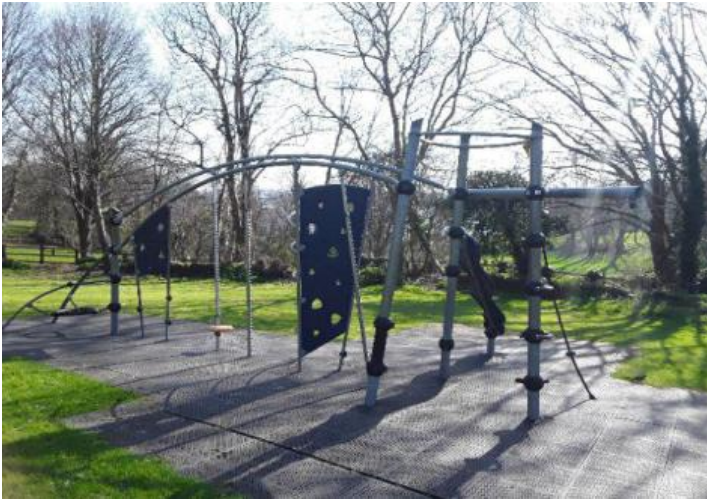
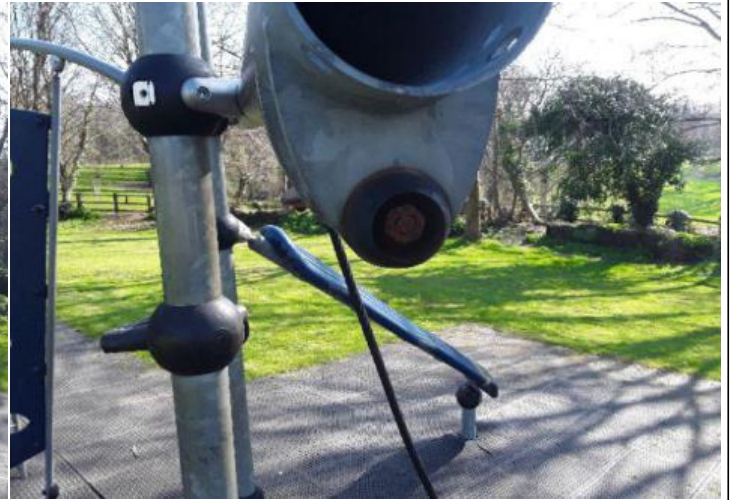
Finding: There is/are bolt cap covers missing or damaged on the item

Action: Replace missing or damaged bolt cap covers

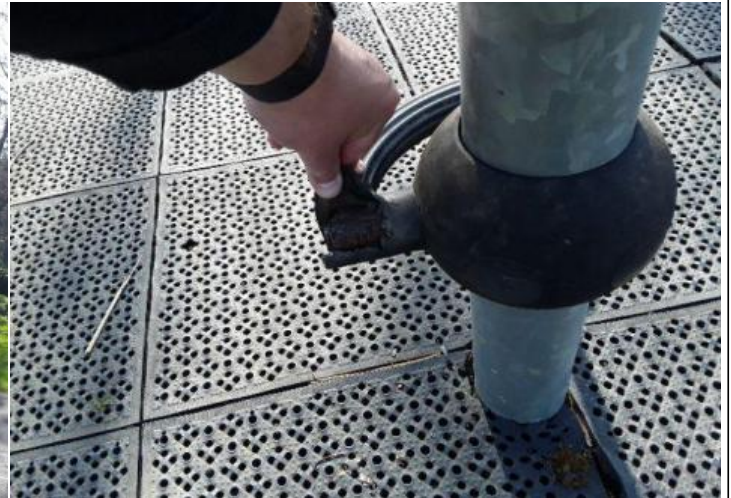
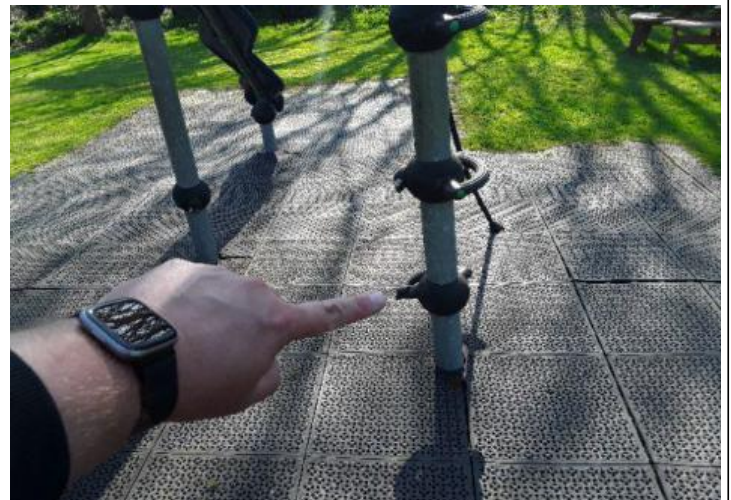
Finding: The rubber covering has been damaged exposing rusty steel

Action: Repair or replace

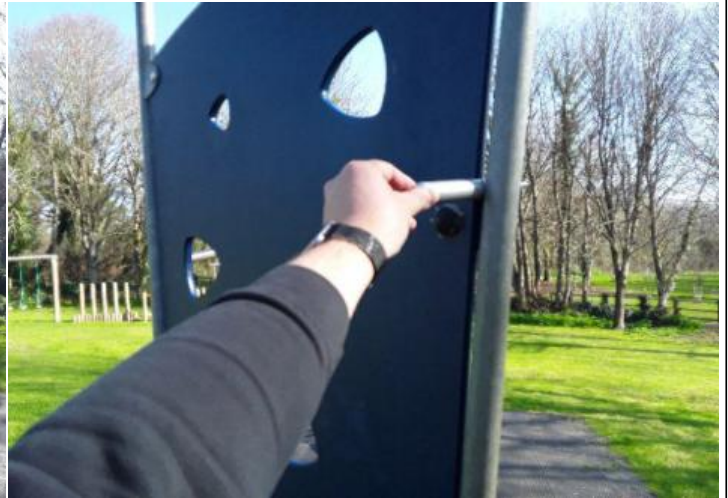
Finding: There is/are finger entrapment/s in the frame and the item fails to meet the requirements of BS EN 1176 Part 1 4.2.7.6 Entrapment of fingers

Action: Monitor - No remedial work recommended

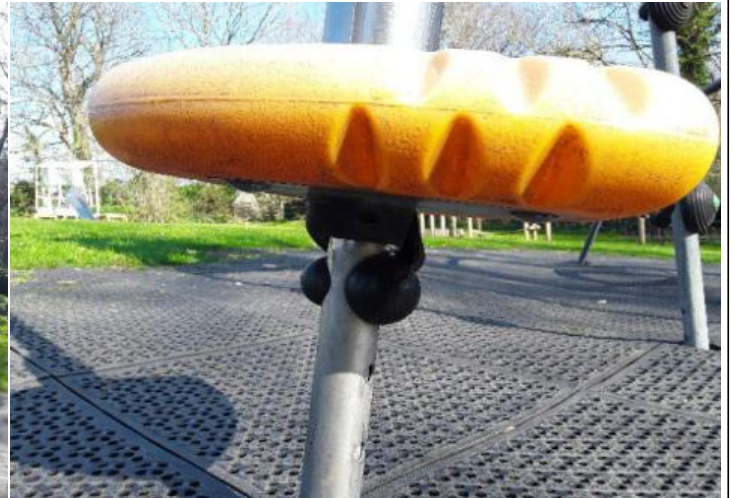
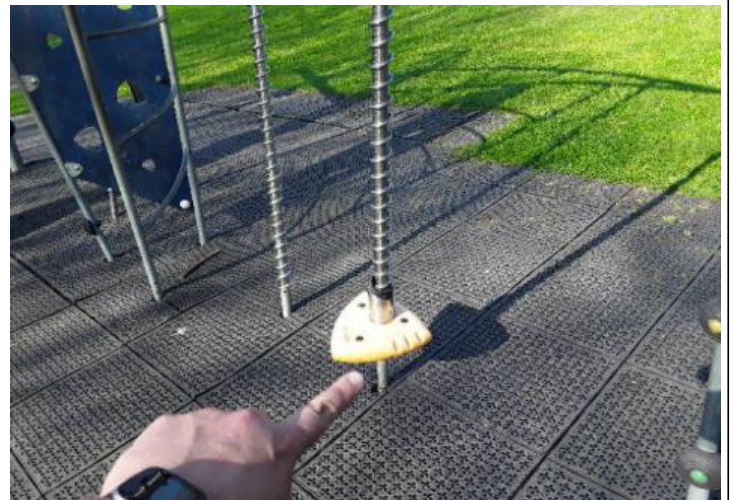
Finding: The rubber bearing cover has been damaged

Action: Monitor for any further deterioration and replace as required

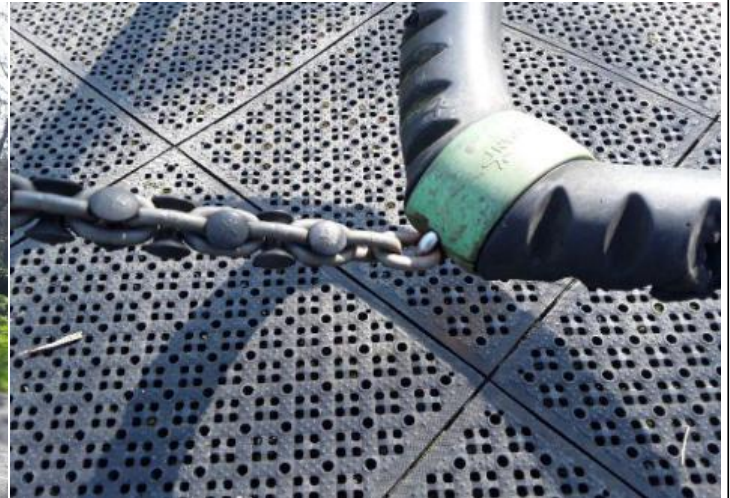
Finding: There is some notable evidence of chain wear

Action: Monitor for any further deterioration and replace when 40% worn

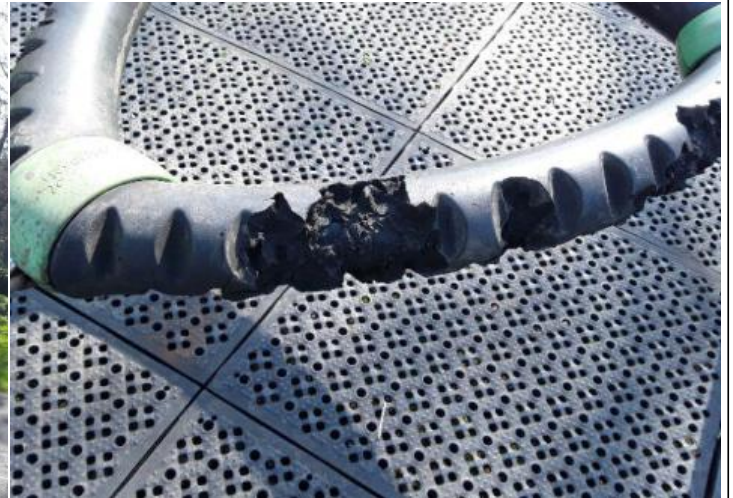
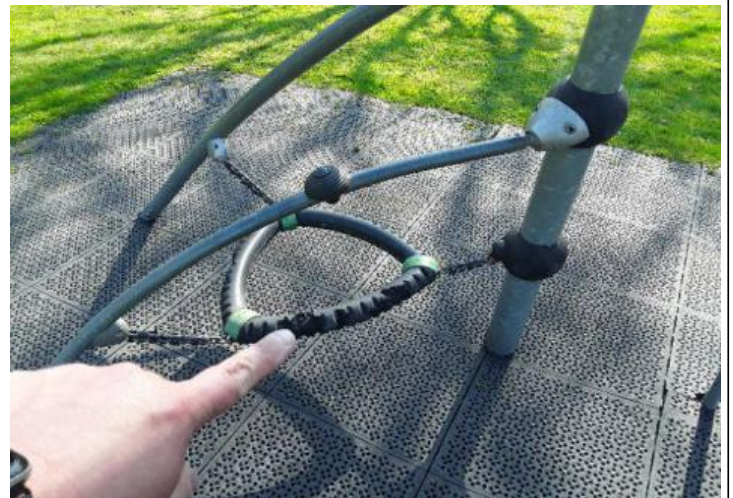
Finding: Part of the rubber ring covering has been damaged **Action:** Monitor for any further deterioration and replace as required

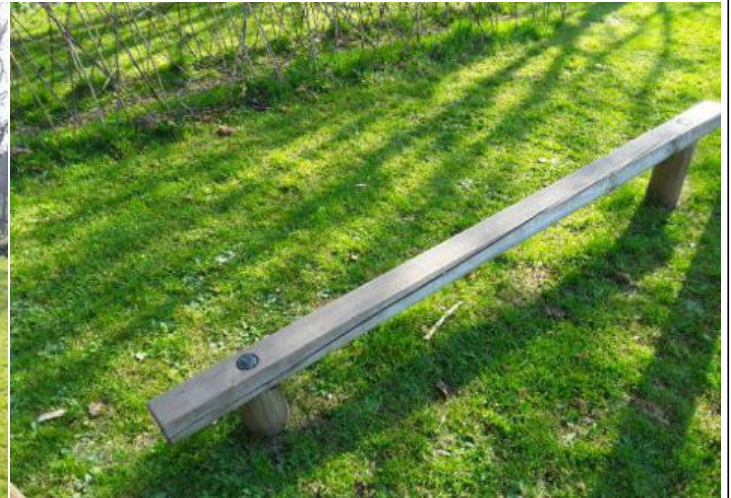
Finding: The timber has a number of splits/shakes or air cracks and this may affect the stability or allow water ingress which will accelerate the rotting process
Action: Monitor to ensure the splits do not cross through fixing points of the structure and/or cause any instability

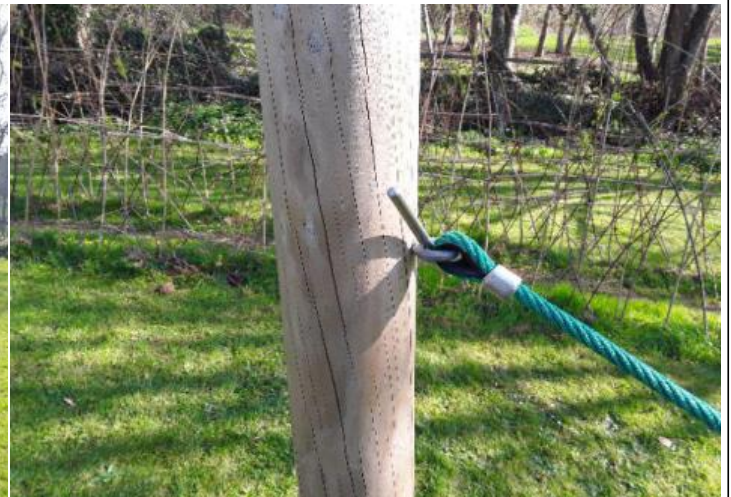
Finding: The connecting links are in excess of 8.6mm and less than 12mm and fail the requirements of BS EN 1176 Part 1; clause 4.2.13, Chains
Action: Monitor - No remedial work recommended

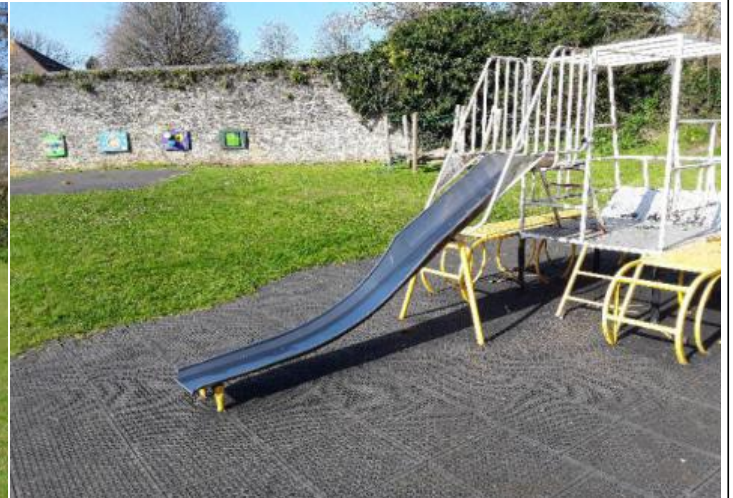
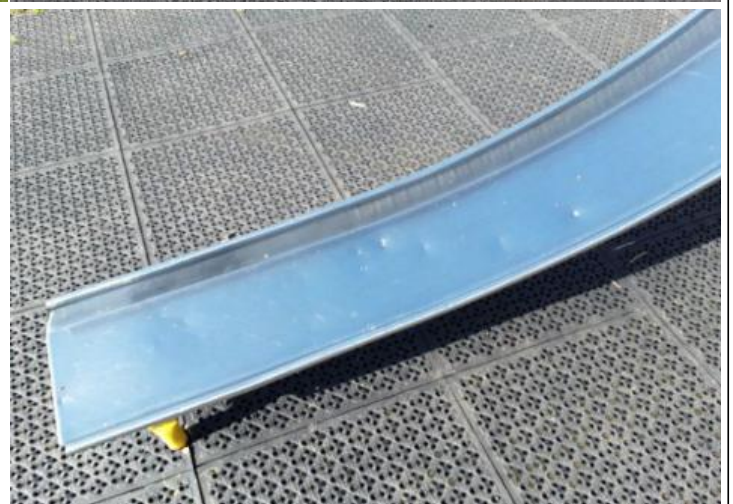
Finding: There are a number of dents in the slide surface

Action: Monitor for any further deterioration and repair as required

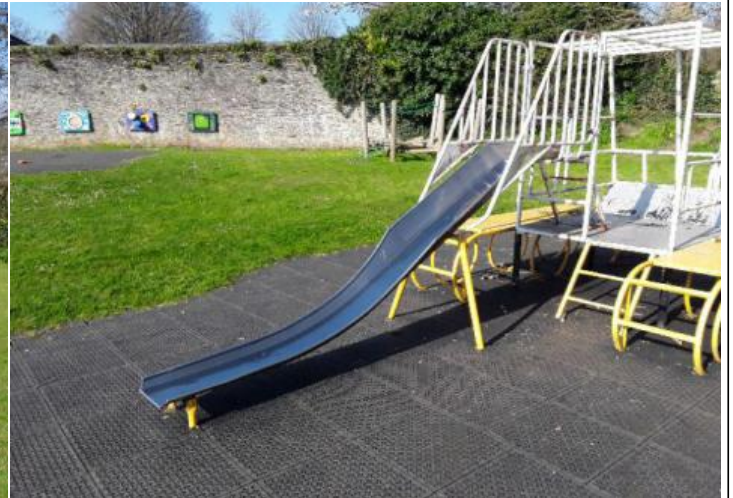
Finding: The slide is predominately south facing and will catch the majority of the sun's heat during the day. Slide surfaces can become very warm during periods of sustained sunny weather

Action: Monitor - No remedial work recommended

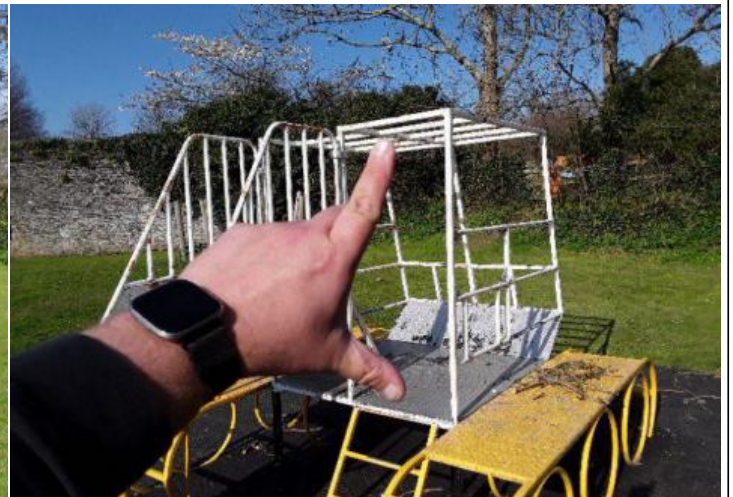
Finding: There are falls in excess of 600mm between adjacent components on the structure, in contravention of the recommendations set out in BS EN 1176 Part 1; 4.2.8.4

Action: Monitor - No remedial work recommended
