the **play inspection** company

Annual Inspection

Torpoint Town Council

Thanckes Park Play Park

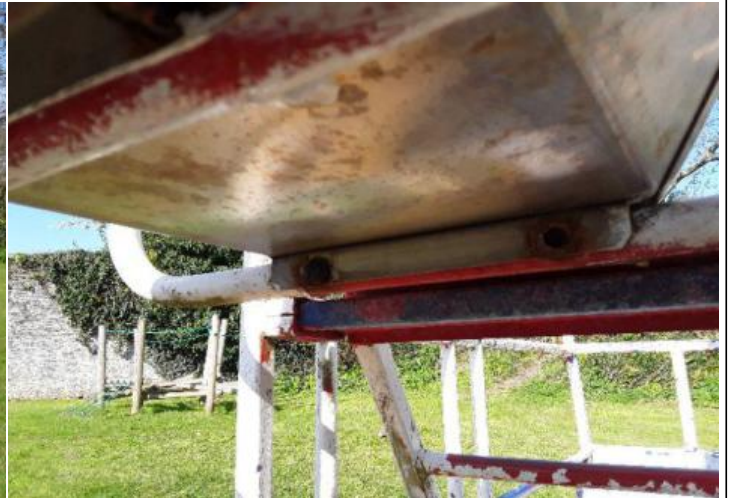
Finding: There is or are fixings missing on the item

Action: Replace all missing fixings

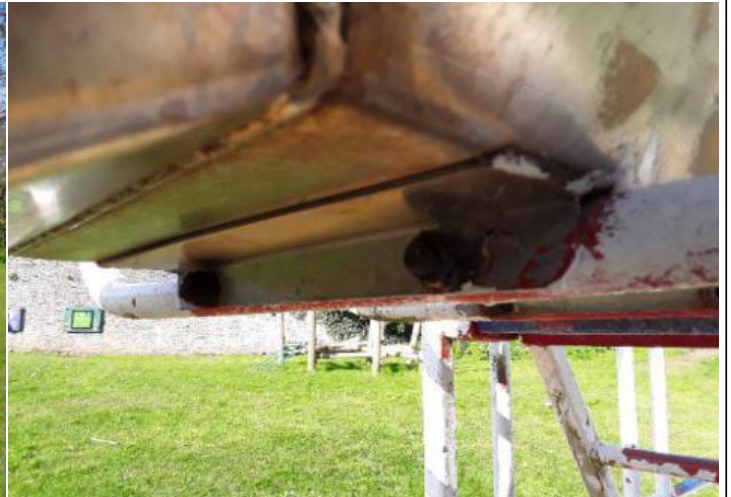
Finding: The fixings have corroded excessively

Action: Replace all corroded fixings

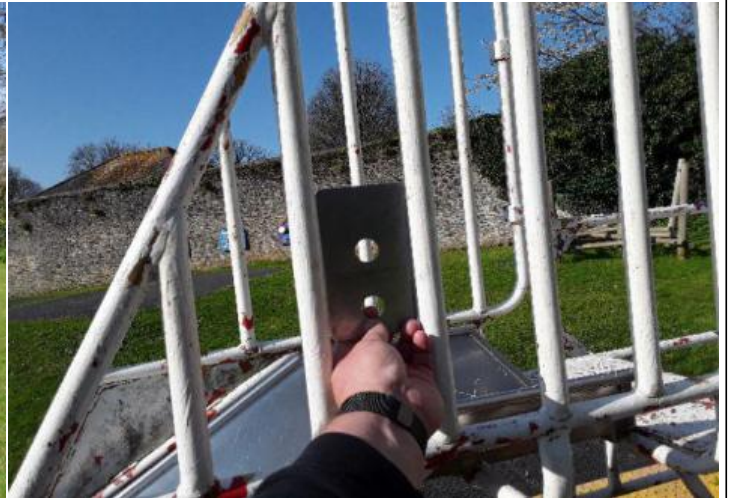
Finding: The item fails to meet the requirements of BS EN 1176 Part 1 4.2.7.2 for head and neck entrapment in the frame

Action: Monitor - No remedial work recommended

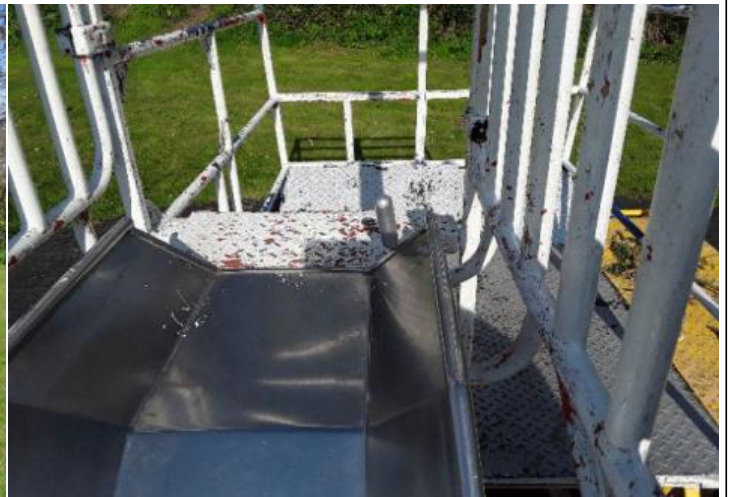
Finding: There is/are finger entrapment/s in the frame and the item fails to meet the requirements of BS EN 1176 Part 1 4.2.7.6 Entrapment of fingers

Action: Monitor - No remedial work recommended

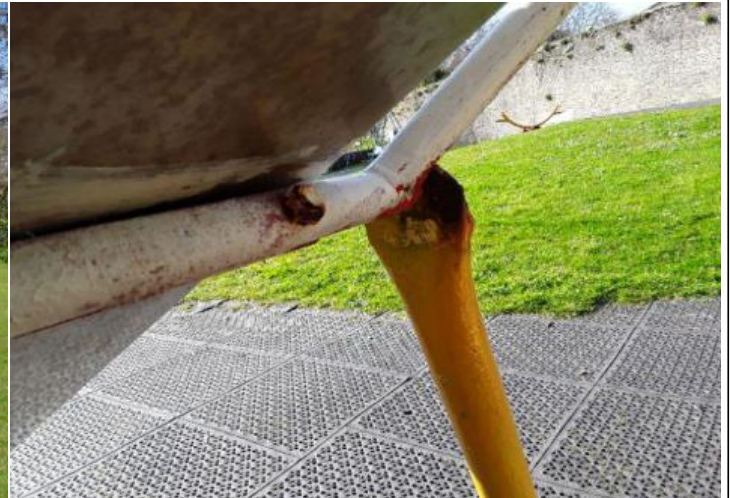
Finding: The paintwork on this item has been damaged or worn exposing the metal underneath which is rusting

Action: Treat any rusting components and repaint

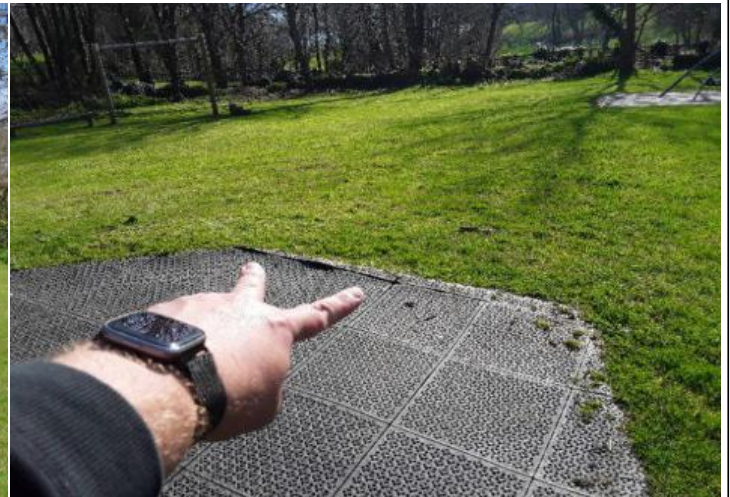
Finding: The surface is lifting at the edges and creating trip points

Action: Repair perimeter of surfacing to remove trip points

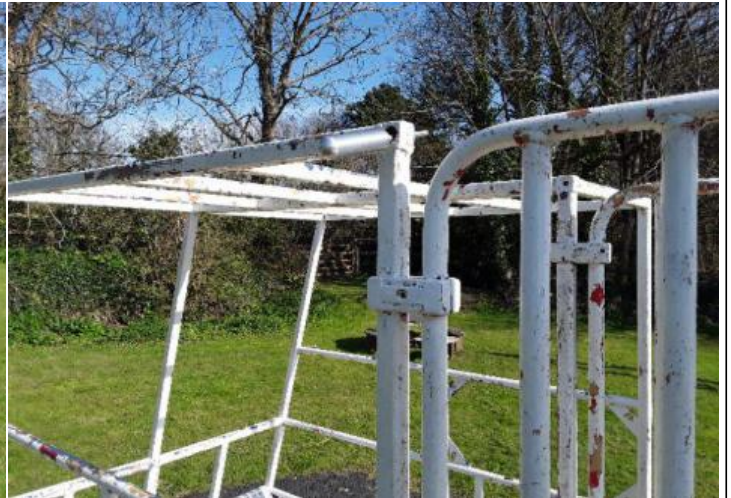
Finding: There is/are finger entrapment/s in the frame due to missing inserts and the item fails to meet the requirements of BS EN 1176 Part 1 4.2.7.6 Entrapment of fingers

Action: Replace the missing inserts to remove the entrapment

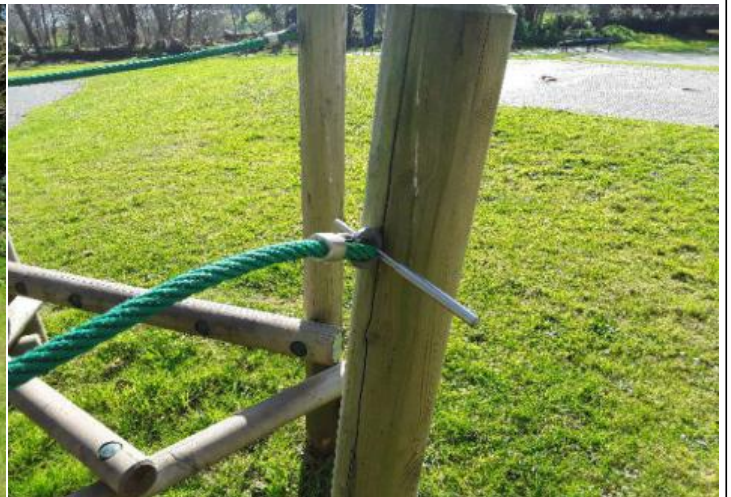
Finding: The connecting links are in excess of 8.6mm and less than 12mm and fail the requirements of BS EN 1176 Part 1; clause 4.2.13, Chains

Action: Monitor - No remedial work recommended

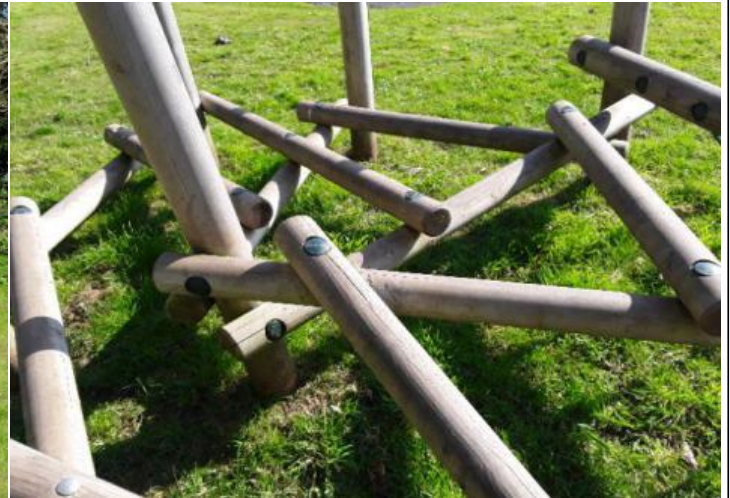
Finding: The timber has a number of splits/shakes or air cracks and this may affect the stability or allow water ingress which will accelerate the rotting process
Action: Monitor to ensure the splits do not cross through fixing points of the structure and/or cause any instability

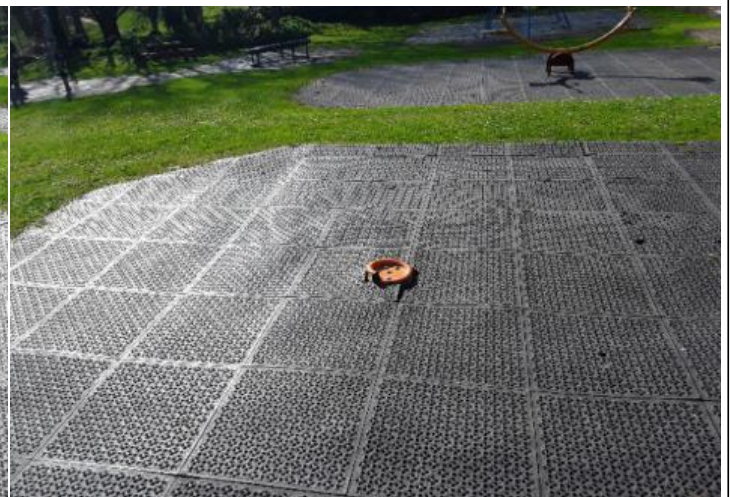
Finding: The spring donkey has been removed but the steel base is still present
Action: Replace the spring donkey or remove the foundation plates

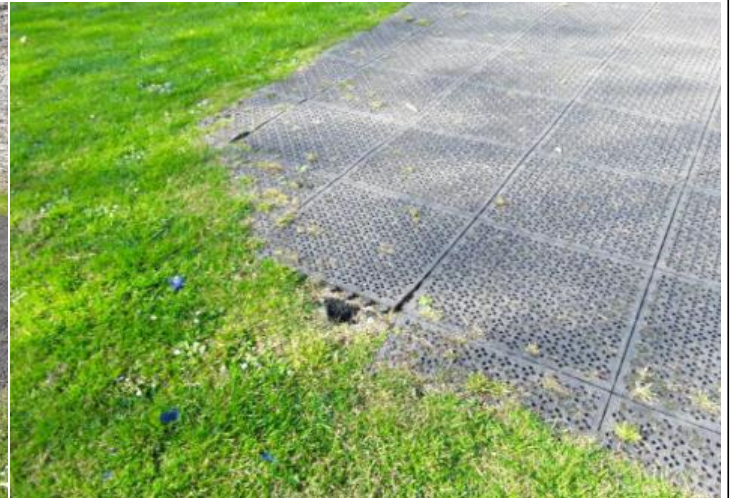
Finding: There is moderate damage to the surface

Action: Repair the damaged areas of surfacing
