the **play inspection** company

Annual Inspection

Torpoint Town Council

Thanckes Park Play Park

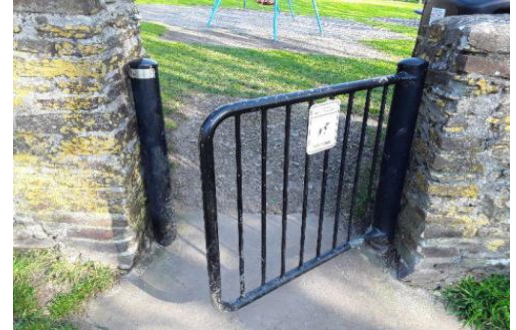
Item: Gate - Self Closing
Manufacturer: Mono Gate Ltd
Surface Type: Concrete
Item Quantity: 1
Equipment Compliance: N/A
Surface Area Compliance: N/A

There is or are fixings missing on the item - Replace all missing fixings

The entrance is becoming uneven - Monitor for any further deterioration or creation of trip points and repair as required

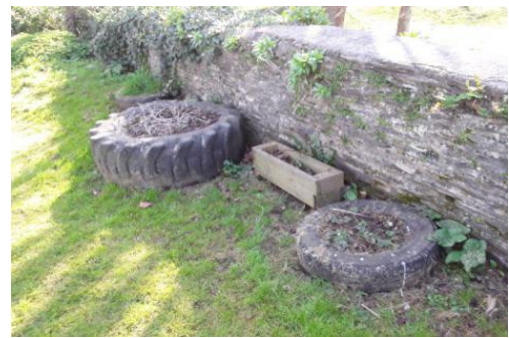
Item: Planting Area
Manufacturer: Not Identified
Surface Type: Grass
Item Quantity: 1
Equipment Compliance: N/A
Surface Area Compliance: N/A

Finding 1
 Some of the planters are not secured and may be subjected to misuse - Monitor use and consider securing the items

Finding 2
 The tyre planter may encourage access onto the top of the wall where there are falls of up to 1.8m to the surface outside of the play area. - Consider relocating the tyre to discourage access onto the wall

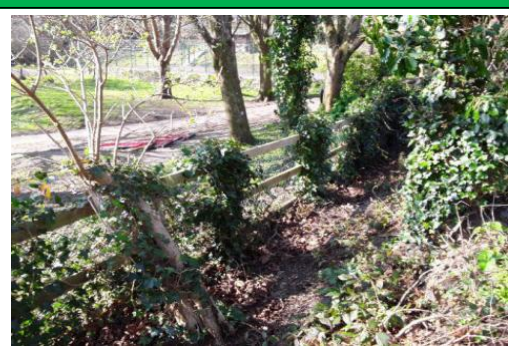
Item: Fence - Timber & Mesh Infill
Manufacturer: Not Identified
Surface Type: Forest Floor
Item Quantity: 1
Equipment Compliance: N/A
Surface Area Compliance: N/A

Finding 1
 There is some evidence of rot in the timber - Monitor for any further deterioration and replace as required

Finding 2
 There is some damage to the fence sections - Monitor for any further deterioration and repair as required

Finding 4
 There is some evidence of rot in the timber posts - Monitor for any further deterioration and replace as required

Finding 5
 There are a number of loose posts around the fence - Monitor for any further deterioration and reset as required

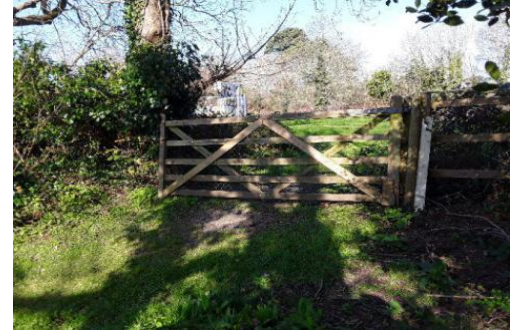
Item: Gate - Maintenance
Manufacturer: Not Identified
Surface Type: Grass
Item Quantity: 1
Equipment Compliance: N/A
Surface Area Compliance: N/A

The gate post has rotted and sheared and is unstable, the additional support posts installed are inadequate to support the structure. - Replace all affected timbers

The item has been damaged - Monitor for any further deterioration and replace as required

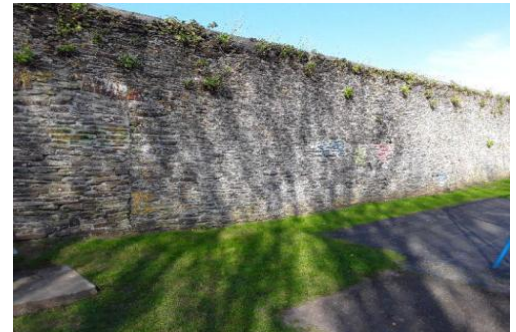
Item: Stone Wall
Manufacturer: Not Identified
Surface Type: Grass
Item Quantity: 1
Equipment Compliance: N/A
Surface Area Compliance: N/A

There is minor damage to the wall - Monitor for any further deterioration and repair as required

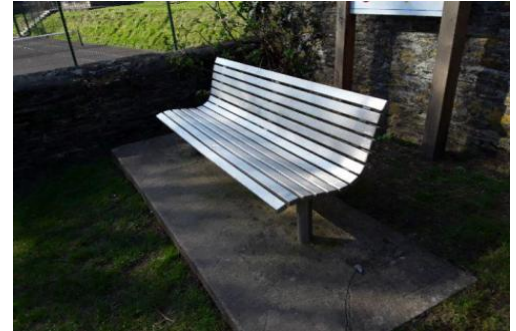
Item: Bench
Manufacturer: Not Identified
Surface Type: Concrete
Item Quantity: 2
Equipment Compliance: N/A
Surface Area Compliance: N/A

The item has been damaged - Monitor for any further deterioration and replace as required

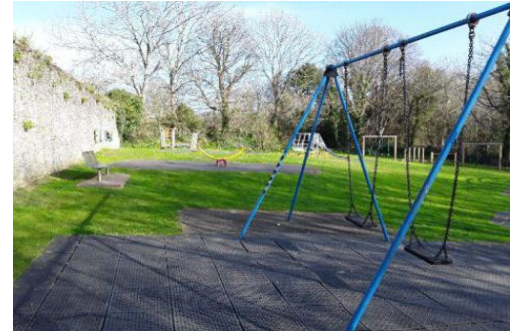
Item: Site General
Manufacturer: Owner/Operator
Surface Type: N/A
Item Quantity: 1
Equipment Compliance: N/A
Surface Area Compliance: N/A

Some of the mats throughout the site have separated, are loose and can be lifted creating trip points - Reinststate surfaces as required

The safety surfaces around the site have been damaged/are wearing - Monitor for any further deterioration and repair as required

A significant section of a tree present on site has fallen. The remaining tree trunk is still upright but may be unstable or in poor health. - Ensure that the tree is inspected by a competent person to ensure ongoing structural integrity. We would recommend that the other trees present on site are also inspected. Remove the fallen section of tree.

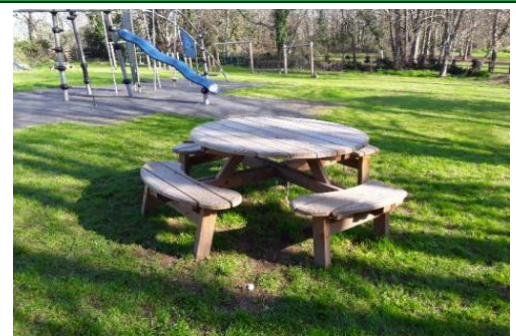
Item: Picnic Table
Manufacturer: Not Identified
Surface Type: Grass
Item Quantity: 2
Equipment Compliance: N/A
Surface Area Compliance: N/A

The table is not secured to the ground and there is some potential for the item to be moved within falling spaces of equipment - Secure the item to the ground

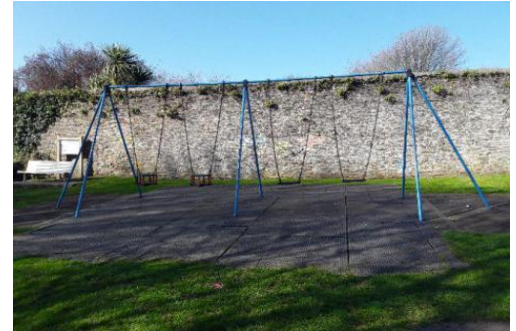
Item: 2 Bay 2 Flat 2 Cradle
Manufacturer: Wicksteed Playgrounds
Surface Type: Matta
Item Quantity: 1
Equipment Compliance: No
Surface Area Compliance: No
Life Expectancy: 5 -10 Years
Total Findings: 8

The paint is flaking off the metalwork - Rub down and re-paint

The bushes are showing signs of wear - Monitor for any further deterioration and replace as required

The chain links are worn in excess of 40% and require renewing - Replace worn chains

The surfacing dimensions are short and do not meet with the requirements of the current applicable standard - Monitor - no remedial action recommended

The seat has minor damage or wear - Monitor for any further deterioration and replace as required

The connecting links are in excess of 8.6mm and less than 12mm and fail the requirements of BS EN 1176 Part 1; clause 4.2.13, Chains - Monitor - No remedial work recommended

The fixings or components for this item were in excess of 2.5m above the standing surface and could not be fully accessed by the inspector. We have completed a visual inspection of the fixings from ground level but a maintenance inspection should be undertaken to assess the condition, security and wear of the components at intervals in accordance with the manufacturers recommendations. - Inspect in accordance with the manufacturers recommendations

The seat is severely damaged and requires replacing - Replace damaged seat

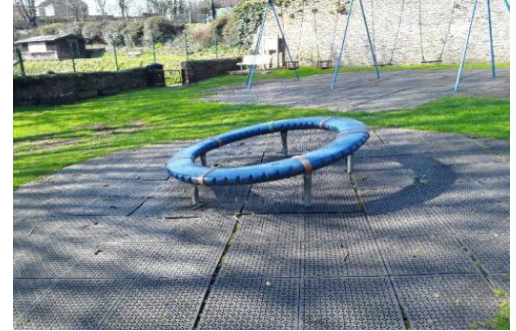
Item: Supernova
Manufacturer: Kompan Ltd
Surface Type: Matta
Item Quantity: 1
Equipment Compliance: Yes
Surface Area Compliance: Yes
Life Expectancy: 3 - 5 Years
Total Findings: 4

The surfacing is very loose beneath this unit creating trip points - Repair as required to secure

There is/are bolt cap covers missing or damaged on the item - Replace missing or damaged bolt cap covers

The casing is cracked in a number of places and rough edges are exposed in two areas - Repair as required

The fixings have corroded excessively - Replace all corroded fixings

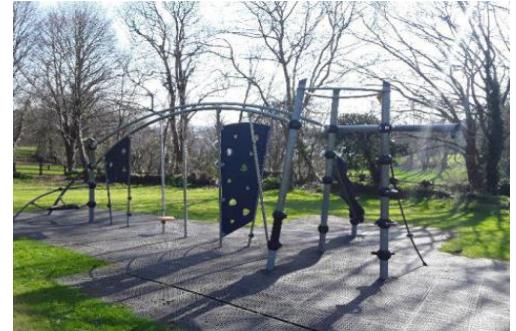
Item: Multi Play (Junior)
Manufacturer: Kompan Ltd
Surface Type: Matta
Item Quantity: 1
Equipment Compliance: No
Surface Area Compliance: Yes
Life Expectancy: 3 - 5 Years
Total Findings: 11

There are significant gaps (over 30mm) between the surface and the edging or between the joints in the surface; these are large enough for a small foot to enter - Repair surfacing

There are post / end caps missing from the item - Replace missing post caps

There is/are finger entrapment/s in the frame due to missing inserts or fixings and the item fails to meet the requirements of BS EN 1176 Part 1 4.2.7.6 Entrapment of fingers - Replace the missing inserts or fixings to remove the entrapment

The multiple has missing component(s) on the structure - Consider replacing missing components

There is/are finger entrapment/s in the frame due to missing fixings and inserts and the item fails to meet the requirements of BS EN 1176 Part 1 4.2.7.6 Entrapment of fingers - Replace the missing inserts or fixings to remove the entrapment

There is/are bolt cap covers missing or damaged on the item - Replace missing or damaged bolt cap covers

The rubber covering has been damaged exposing rusty steel - Repair or replace

There is/are finger entrapment/s in the frame and the item fails to meet the requirements of BS EN 1176 Part 1 4.2.7.6 Entrapment of fingers - Monitor - No remedial work recommended

The rubber bearing cover has been damaged - Monitor for any further deterioration and replace as required

There is some notable evidence of chain wear - Monitor for any further deterioration and replace when 40% worn

Part of the rubber ring covering has been damaged - Monitor for any further deterioration and replace as required

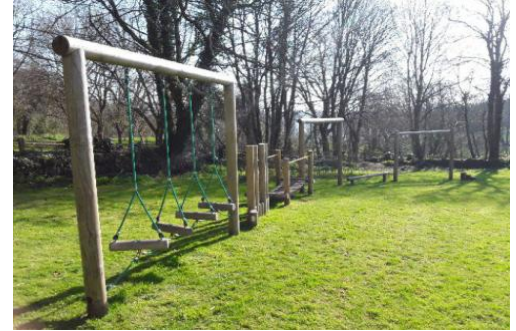
Item: Activity Trail
Manufacturer: Wicksteed Playgrounds
Surface Type: Grass
Item Quantity: 1
Equipment Compliance: No
Surface Area Compliance: Yes
Life Expectancy: 5 -10 Years
Total Findings: 2

The timber has a number of splits/shakes or air cracks and this may affect the stability or allow water ingress which will accelerate the rotting process - Monitor to ensure the splits do not cross through fixing points of the structure and/or cause any instability

The connecting links are in excess of 8.6mm and less than 12mm and fail the requirements of BS EN 1176 Part 1; clause 4.2.13, Chains - Monitor - No remedial work recommended

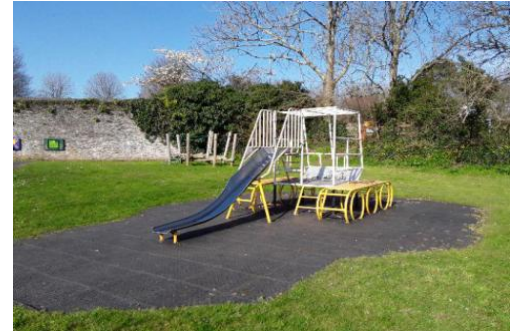
Item: Climbing Frame
Manufacturer: Wicksteed Playgrounds
Surface Type: Matta
Item Quantity: 1
Equipment Compliance: No
Surface Area Compliance: Yes
Life Expectancy: 3 - 5 Years
Total Findings: 10

There are a number of dents in the slide surface - Monitor for any further deterioration and repair as required

The slide is predominately south facing and will catch the majority of the sun's heat during the day. Slide surfaces can become very warm during periods of sustained sunny weather - Monitor - No remedial work recommended

There are falls in excess of 600mm between adjacent components on the structure, in contravention of the recommendations set out in BS EN 1176 Part 1; 4.2.8.4 - Monitor - No remedial work recommended

There is or are fixings missing on the item - Replace all missing fixings

The fixings have corroded excessively - Replace all corroded fixings

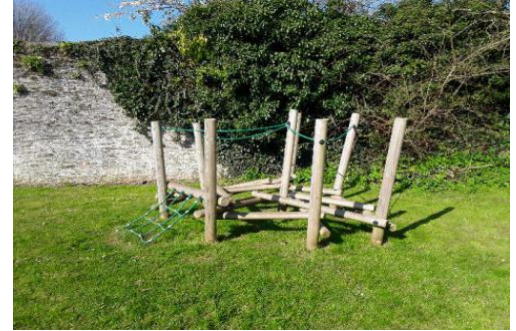
Item: Log Climber
Manufacturer: Wicksteed Playgrounds
Surface Type: Grass
Item Quantity: 1
Equipment Compliance: No
Surface Area Compliance: Yes
Life Expectancy: 5 -10 Years
Total Findings: 2

The connecting links are in excess of 8.6mm and less than 12mm and fail the requirements of BS EN 1176 Part 1; clause 4.2.13, Chains - Monitor - No remedial work recommended

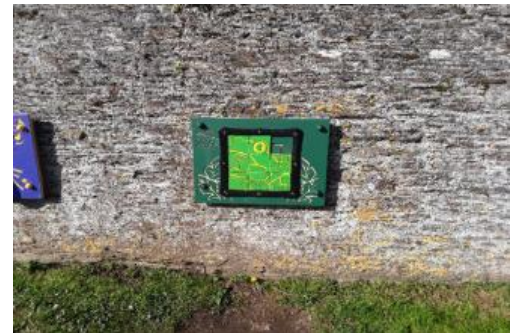
Item: Play Panel
Manufacturer: Not Identified
Surface Type: Grass
Item Quantity: 1
Equipment Compliance: Yes
Surface Area Compliance: N/A
Life Expectancy: 5 -10 Years
Total Findings: 1

This item is satisfactory - no work required -

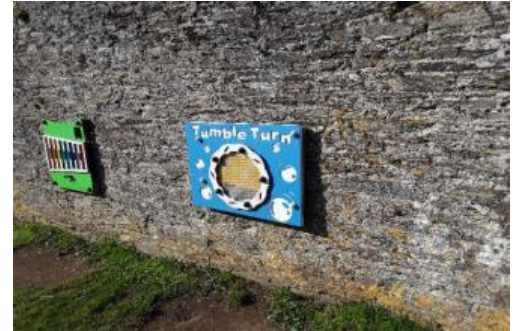
Item: Play Panel
Manufacturer: Not Identified
Surface Type: Grass
Item Quantity: 1
Equipment Compliance: Yes
Surface Area Compliance: N/A
Life Expectancy: 5 -10 Years
Total Findings: 1

This item is satisfactory - no work required -

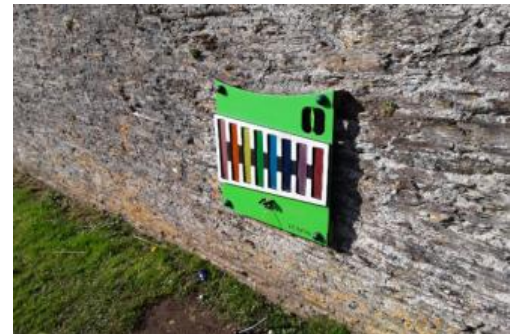
Item: Musical Instrument
Manufacturer: Hags
Surface Type: Grass
Item Quantity: 1
Equipment Compliance: Yes
Surface Area Compliance: N/A
Life Expectancy: 5 -10 Years
Total Findings: 1

This item is satisfactory - no work required -

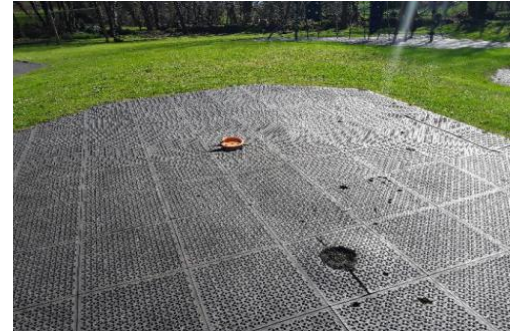
Item: Spring Donkey
Manufacturer: Wicksteed Playgrounds
Surface Type: Matta
Item Quantity: 1
Equipment Compliance: Yes
Surface Area Compliance: Yes
Life Expectancy: <12 Months
Total Findings: 1

The spring donkey has been removed but the steel base is still present - Replace the spring donkey or remove the foundation plates

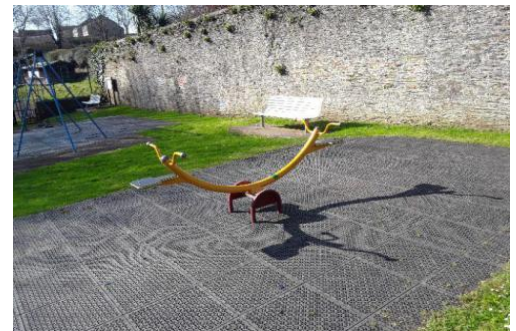
Item: See Saw
Manufacturer: Wicksteed Playgrounds
Surface Type: Matta
Item Quantity: 1
Equipment Compliance: Yes
Surface Area Compliance: Yes
Life Expectancy: 5 -10 Years
Total Findings: 1

There is moderate damage to the surface - Repair the damaged areas of surfacing

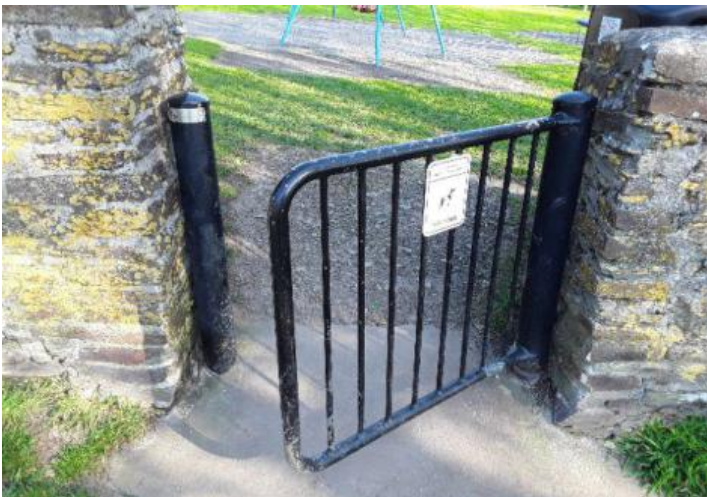
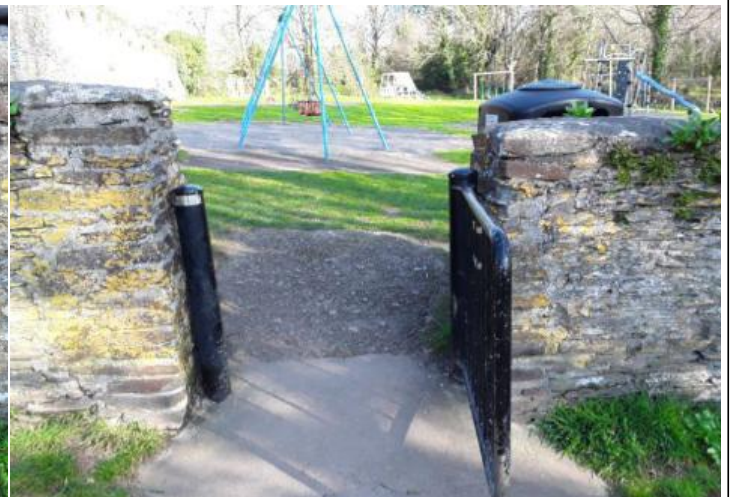
Item: Gates - Gate - Self Closing
Manufacturer: Mono Gate Ltd

Finding: The gate is not operating correctly

Action: Take effective action to ensure the gate closes between 4 and 8 seconds

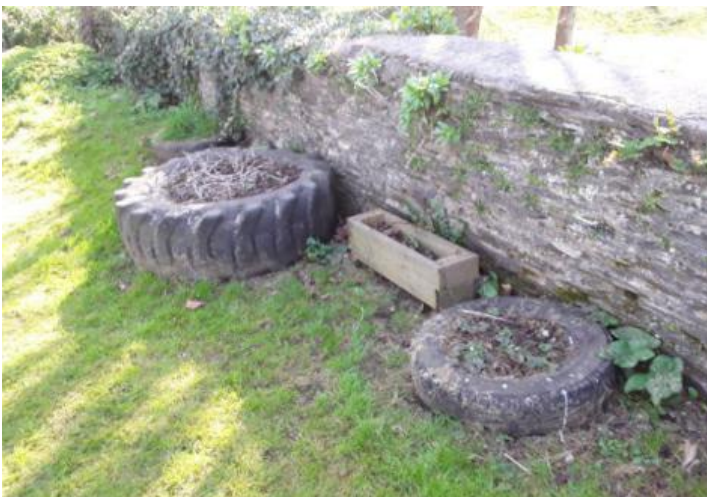
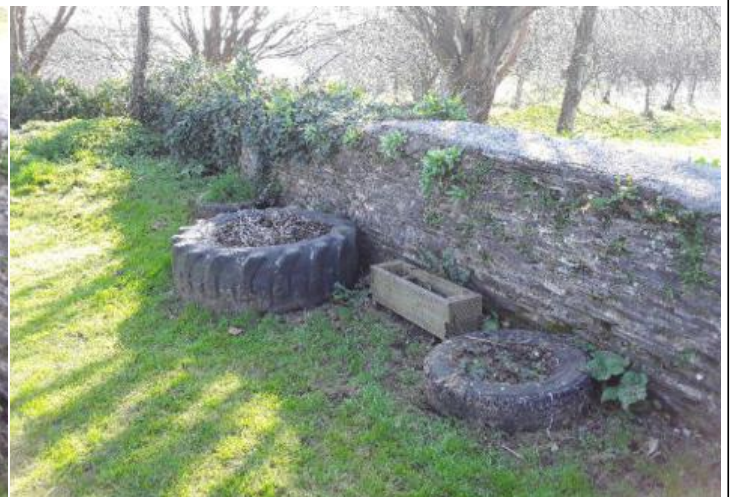
Item: Other - Planting Area
Manufacturer: Not Identified

Finding: Some of the planters are not secured and may be subjected to misuse

Action: Monitor use and consider securing the items

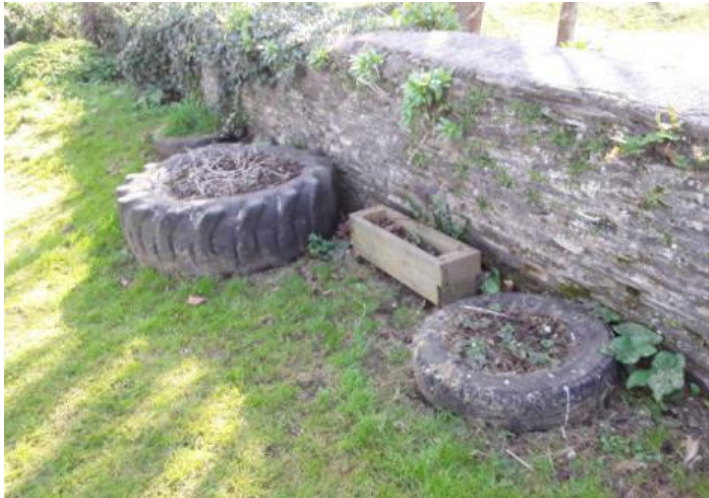
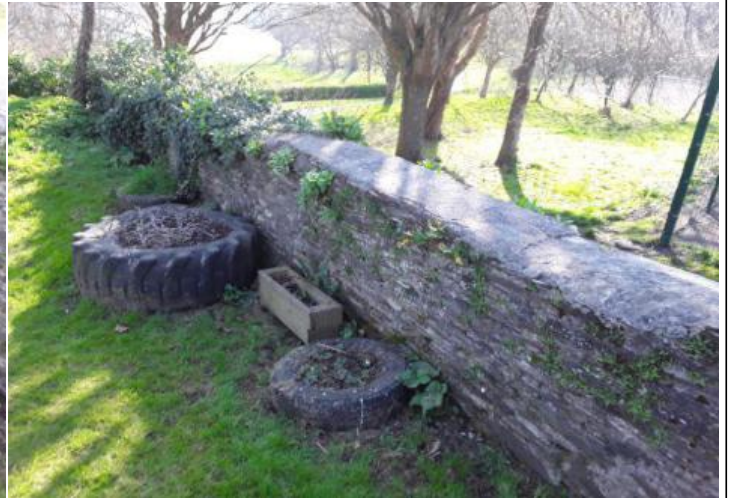
Item: Other - Planting Area
Manufacturer: Not Identified

Finding: The tyre planter may encourage access onto the top of the wall where there are falls of up to 1.8m to the surface outside of the play area.

Action: Consider relocating the tyre to discourage access onto the wall

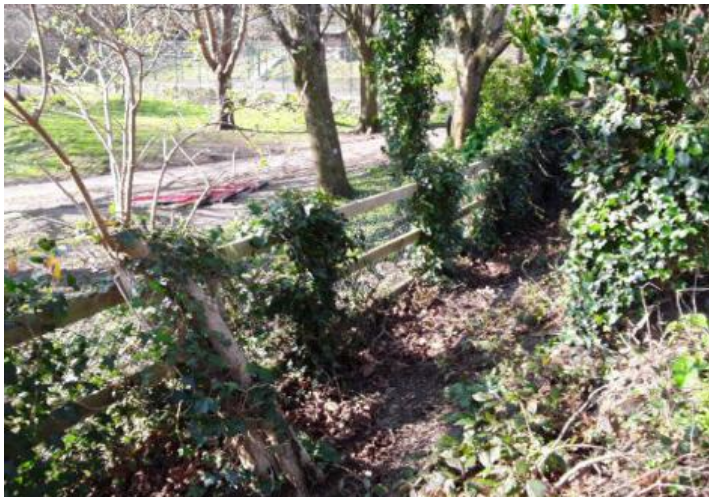
Item: Fences - Fence - Timber & Mesh Infill
Manufacturer: Not Identified

Finding: There is some evidence of rot in the timber

Action: Monitor for any further deterioration and replace as required

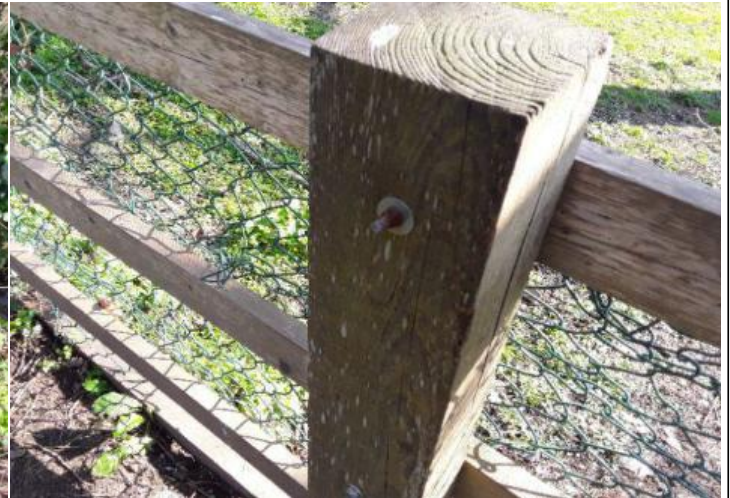
Item: Fences - Fence - Timber & Mesh Infill
Manufacturer: Not Identified
Risk Level: L - Low Risk
Surface: Forest Floor

Finding: There are projecting bolt thread(s) present
Action: Remove excess thread length and deburr or provide cap

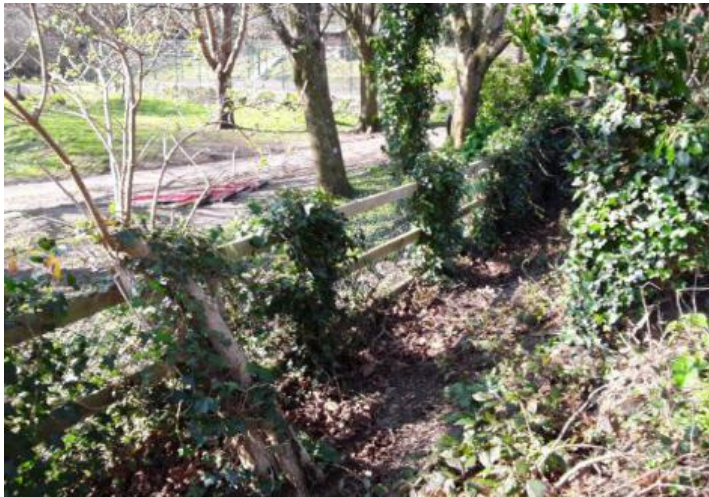
Item: Fences - Fence - Timber & Mesh Infill
Manufacturer: Not Identified
Risk Level: L - Low Risk
Surface: Forest Floor

Finding: There is some evidence of rot in the timber posts
Action: Monitor for any further deterioration and replace as required

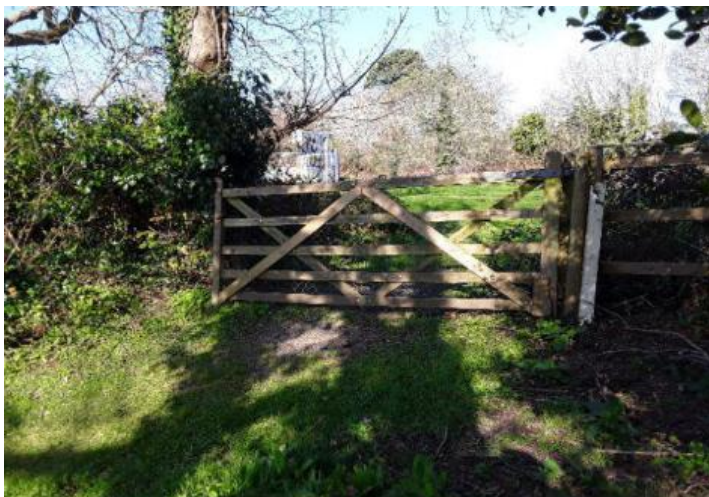
Item: Gates - Gate - Maintenance
Manufacturer: Not Identified

Finding: The gate post has rotted and sheared and is unstable, the additional support posts installed are inadequate to support the structure.

Action: Replace all affected timbers

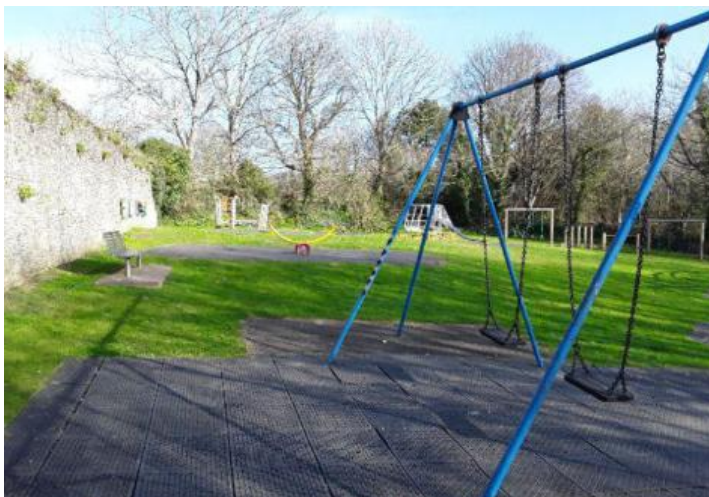
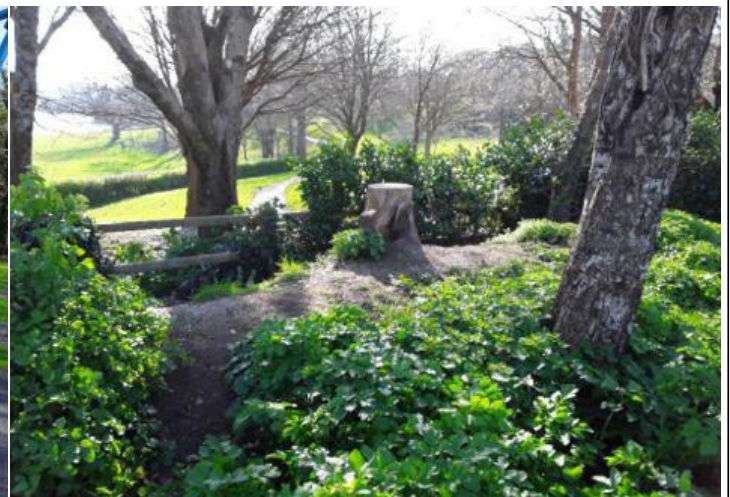
Item: Ancillary Items - Site General
Manufacturer: Owner/Operator

Finding: There is an accessible tree stump present within the play area that may be climbed and has falls in excess of 600mm (approximately 1.0m) onto the remains of a stone wall beneath.

Action: Remove the remaining stump or reduce the height to reduce any potential falls to less than 600mm.

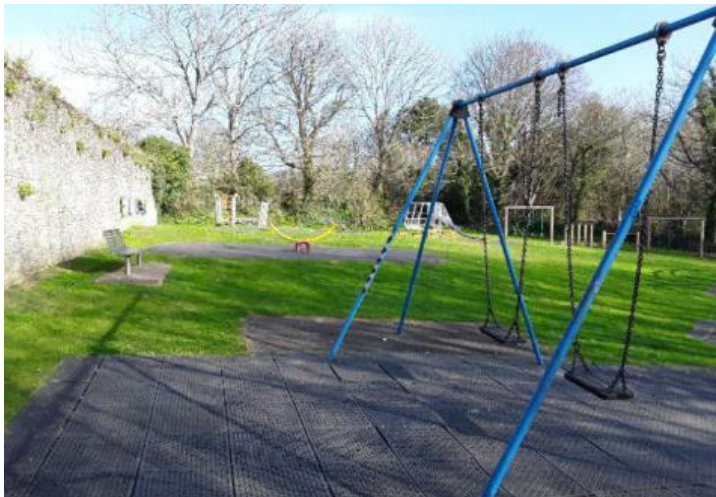
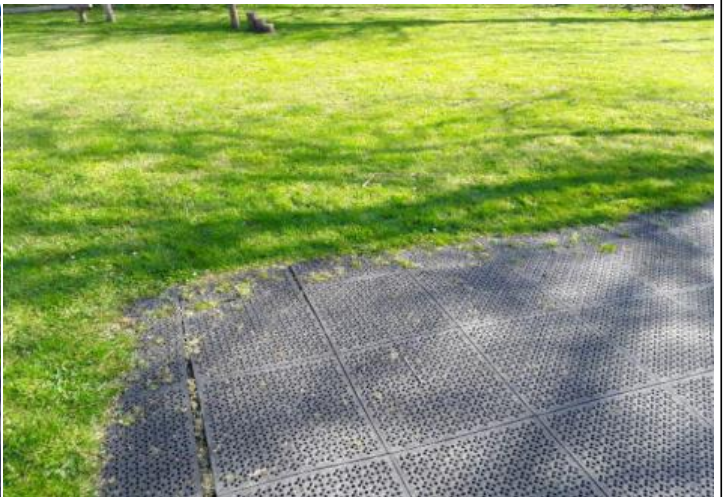
Item: Ancillary Items - Site General
Manufacturer: Owner/Operator

Finding: There is weed / vegetation growth on, between, or around the edges of the surfacing

Action: Remove weed / vegetation growth

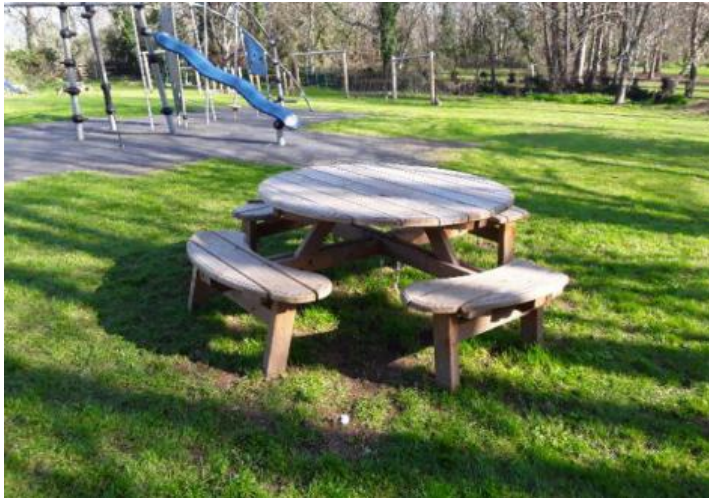
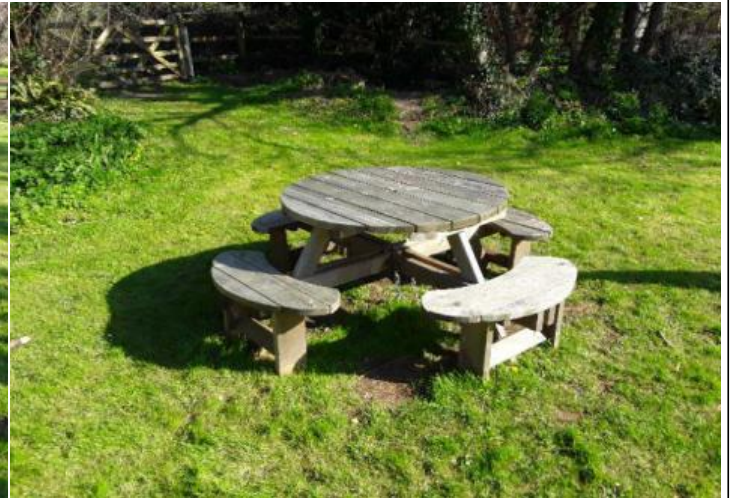
Finding: The table is not secured to the ground and there is some potential for the item to be moved within falling spaces of equipment
Action: Secure the item to the ground

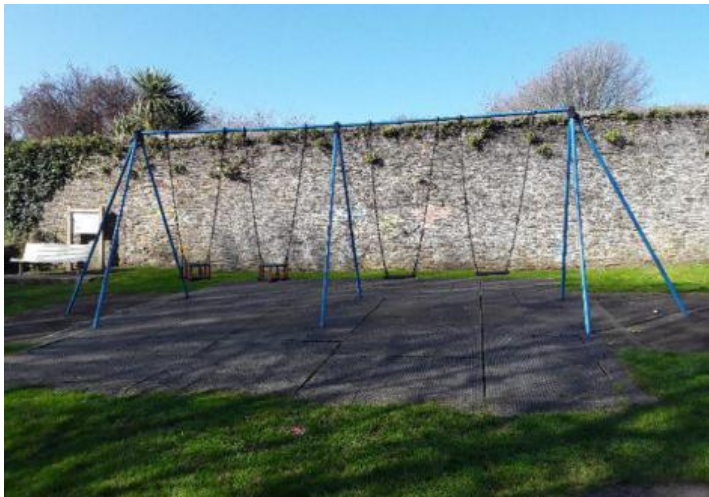
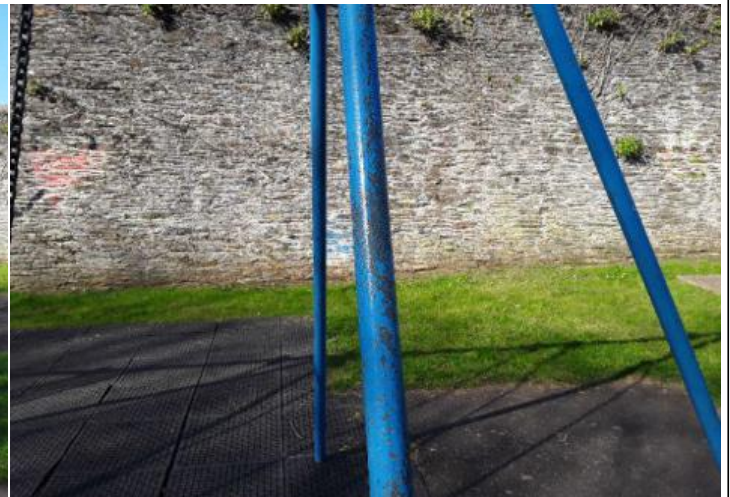
Finding: The paint is flaking off the metalwork
Action: Rub down and re-paint

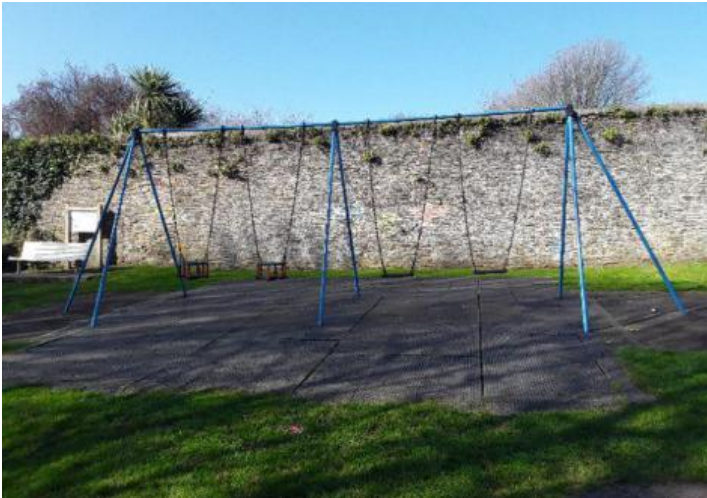
Finding: The seat has minor damage or wear

Action: Monitor for any further deterioration and replace as required

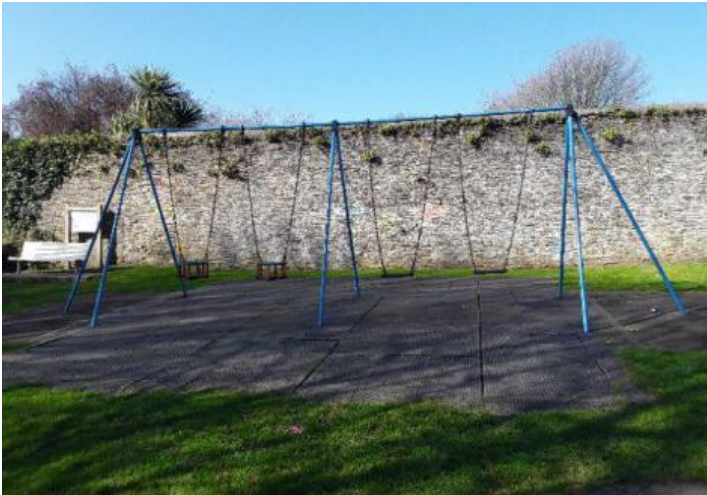
Finding: The bushes are showing signs of wear

Action: Monitor for any further deterioration and replace as required

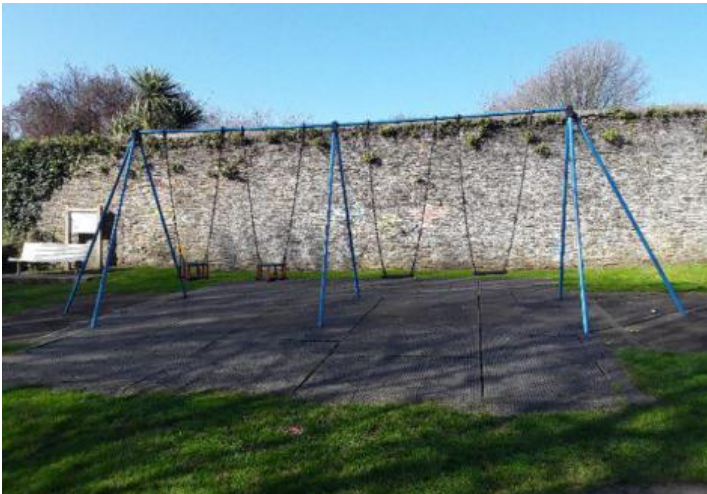
Finding: The connecting links are in excess of 8.6mm and less than 12mm and fail the requirements of BS EN 1176 Part 1; clause 4.2.13, Chains

Action: Monitor - No remedial work recommended

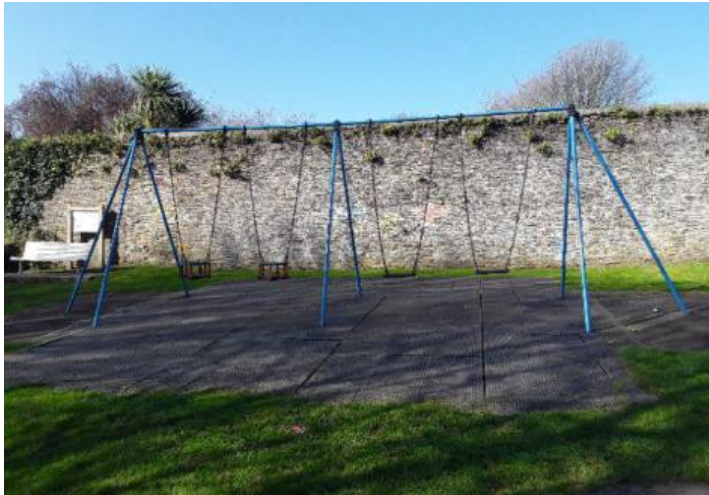
Finding: The surfacing dimensions are short and do not meet with the requirements of the current applicable standard

Action: Monitor - no remedial action recommended

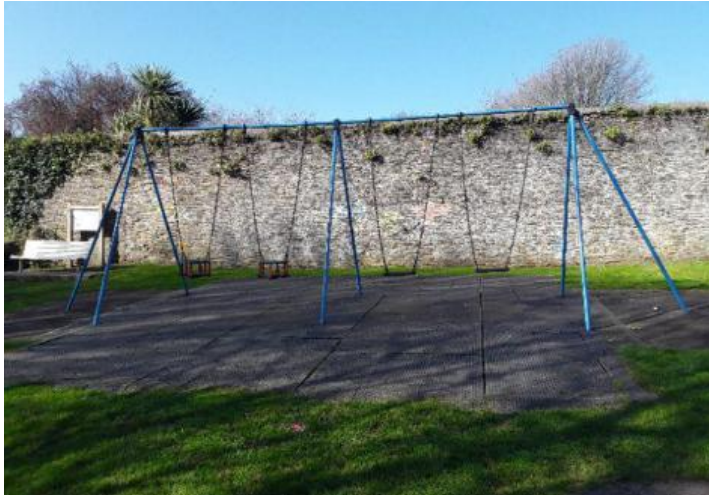
Finding: The seat is severely damaged and requires replacing

Action: Replace damaged seat

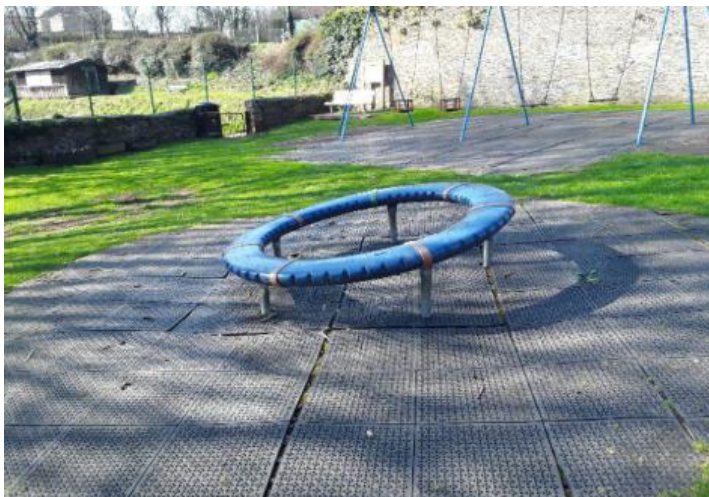
Finding: The casing is cracked in a number of places and rough edges are exposed in two areas

Action: Repair as required

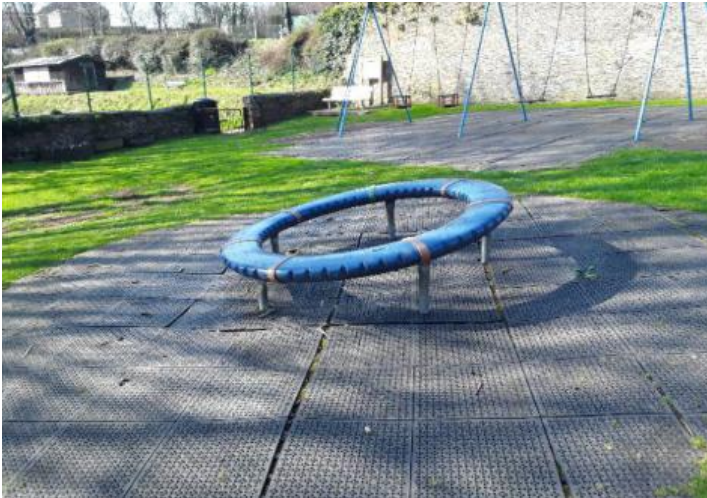
Finding: There is/are bolt cap covers missing or damaged on the item

Action: Replace missing or damaged bolt cap covers

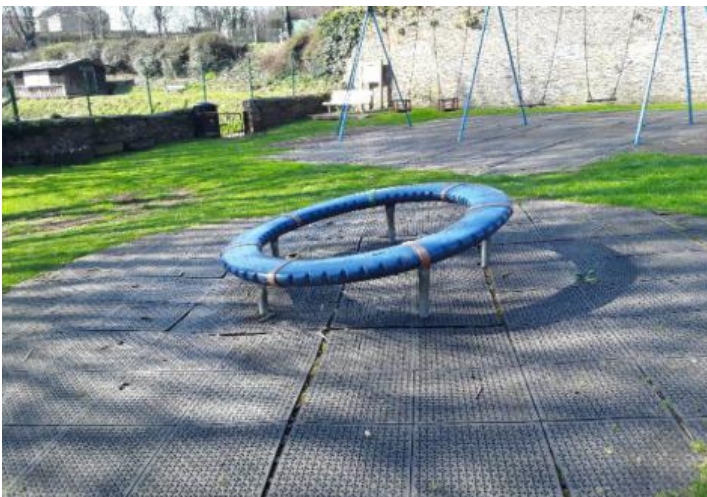
Finding: The fixings have corroded excessively

Action: Replace all corroded fixings

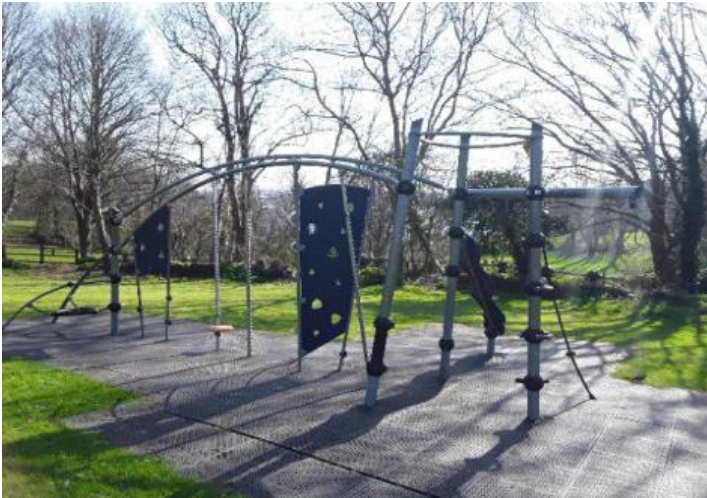
Finding: There are significant gaps (over 30mm) between the surface and the edging or between the joints in the surface; these are large enough for a small foot to enter

Action: Repair surfacing

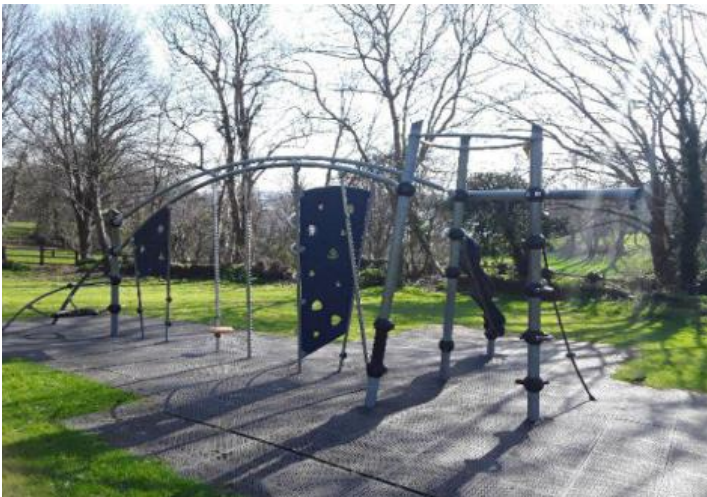
Finding: There are post / end caps missing from the item

Action: Replace missing post caps

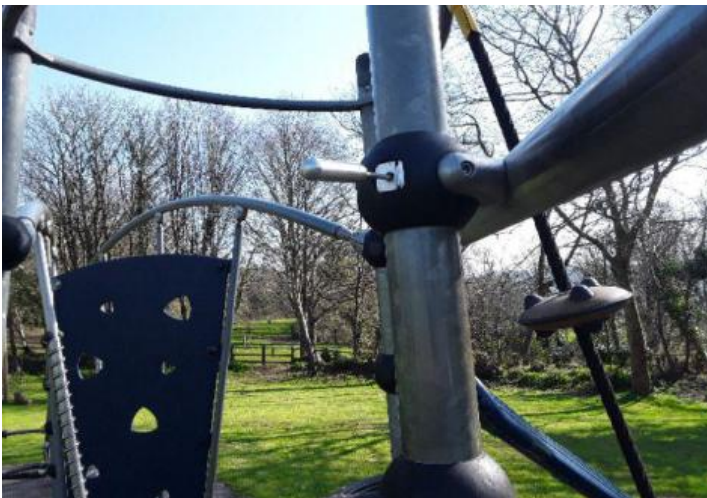
Finding: There is/are finger entrapment/s in the frame due to missing fixings and inserts and the item fails to meet the requirements of BS EN 1176 Part 1 4.2.7.6 Entrapment of fingers

Action: Replace the missing inserts or fixings to remove the entrapment

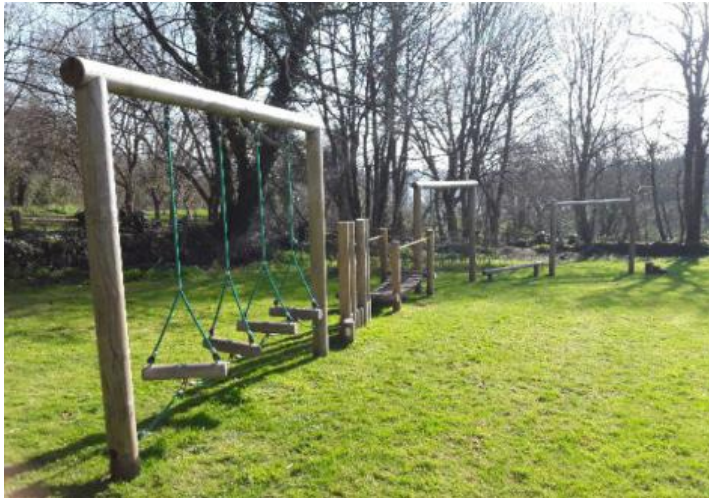
Finding: The timber has a number of splits/shakes or air cracks and this may affect the stability or allow water ingress which will accelerate the rotting process
Action: Monitor to ensure the splits do not cross through fixing points of the structure and/or cause any instability

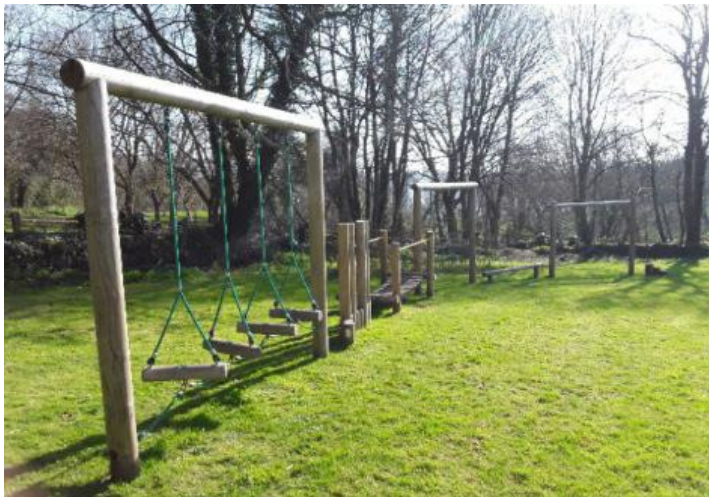
Finding: The connecting links are in excess of 8.6mm and less than 12mm and fail the requirements of BS EN 1176 Part 1; clause 4.2.13, Chains
Action: Monitor - No remedial work recommended

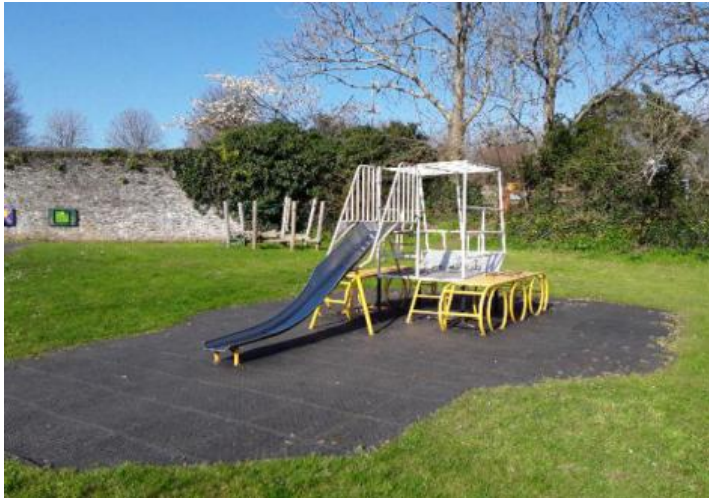
Finding: There are a number of dents in the slide surface

Action: Monitor for any further deterioration and repair as required

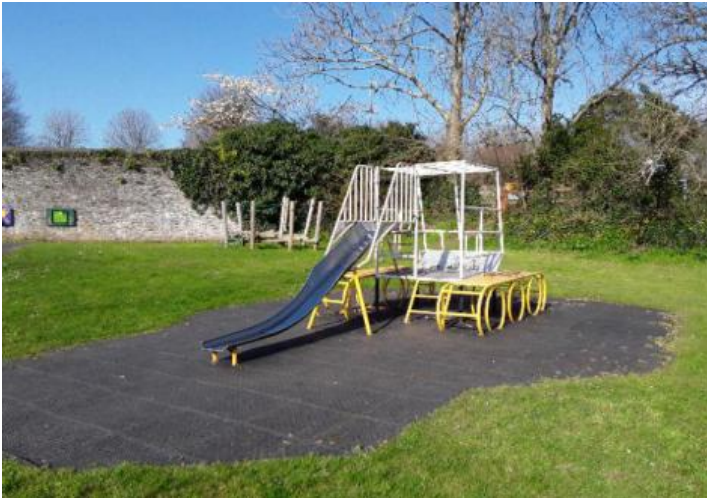
Finding: The slide is predominately south facing and will catch the majority of the sun's heat during the day. Slide surfaces can become very warm during periods of sustained sunny weather

Action: Monitor - No remedial work recommended

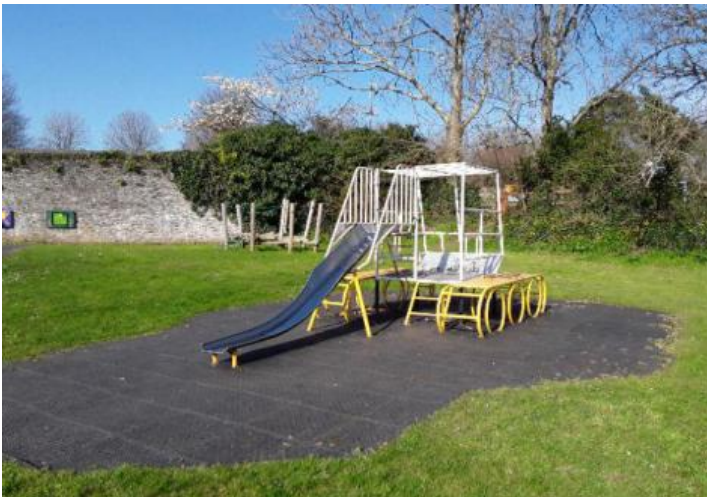
Finding: There are falls in excess of 600mm between adjacent components on the structure, in contravention of the recommendations set out in BS EN 1176 Part 1; 4.2.8.4

Action: Monitor - No remedial work recommended

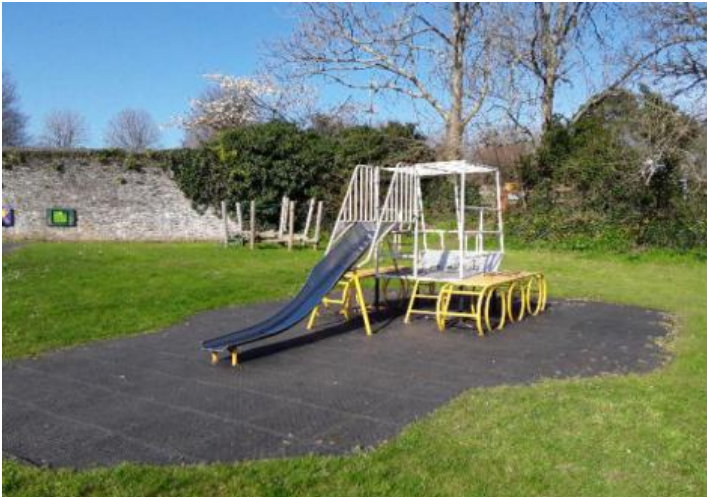
Finding: The fixings have corroded excessively

Action: Replace all corroded fixings

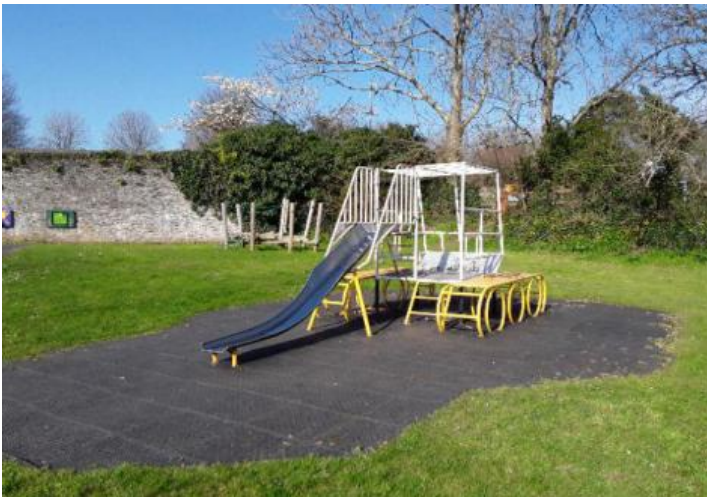
There is/are finger entrapment/s in the frame and the item fails to meet the requirements of BS EN 1176 Part 1 4.2.7.6 Entrapment of fingers - Monitor - No remedial work recommended

Finding: There is/are finger entrapment/s in the frame and the item fails to meet the requirements of BS EN 1176 Part 1 4.2.7.6 Entrapment of fingers

Action: Monitor - No remedial work recommended

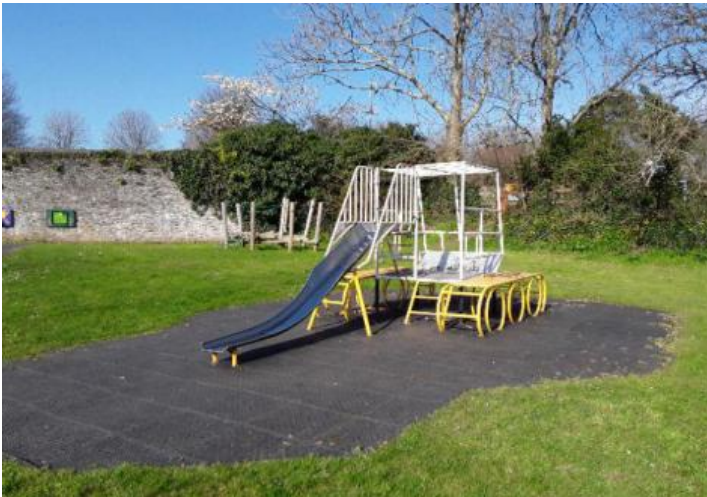
The surface is lifting at the edges and creating trip points - Repair perimeter of surfacing to remove trip points

Finding: The surface is lifting at the edges and creating trip points

Action: Repair perimeter of surfacing to remove trip points

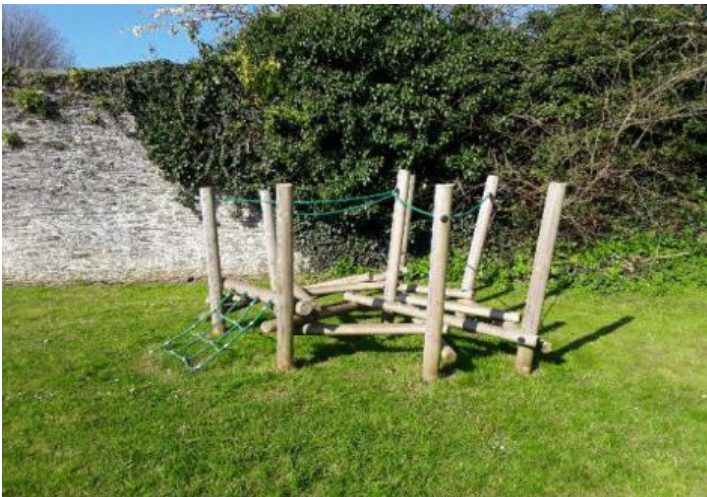
Finding: The connecting links are in excess of 8.6mm and less than 12mm and fail the requirements of BS EN 1176 Part 1; clause 4.2.13, Chains

Action: Monitor - No remedial work recommended

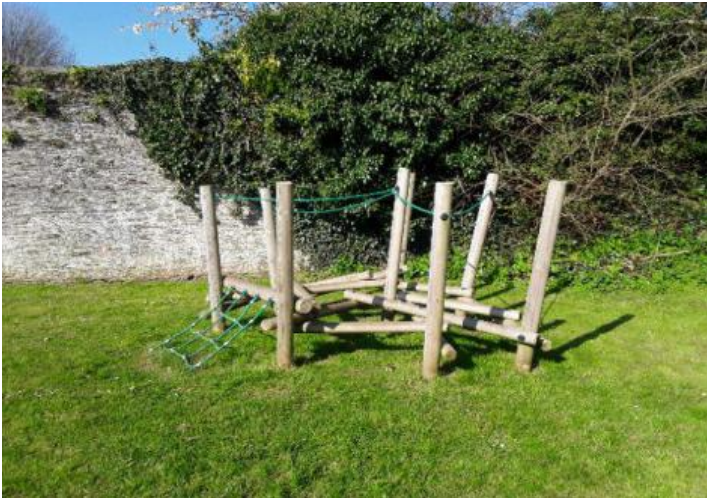
The timber has a number of splits/shakes or air cracks and this may affect the stability or allow water ingress which will accelerate the rotting process - Monitor to ensure the splits do not cross through fixing points of the structure and/or cause any instability

Finding: The timber has a number of splits/shakes or air cracks and this may affect the stability or allow water ingress which will accelerate the rotting process
Action: Monitor to ensure the splits do not cross through fixing points of the structure and/or cause any instability

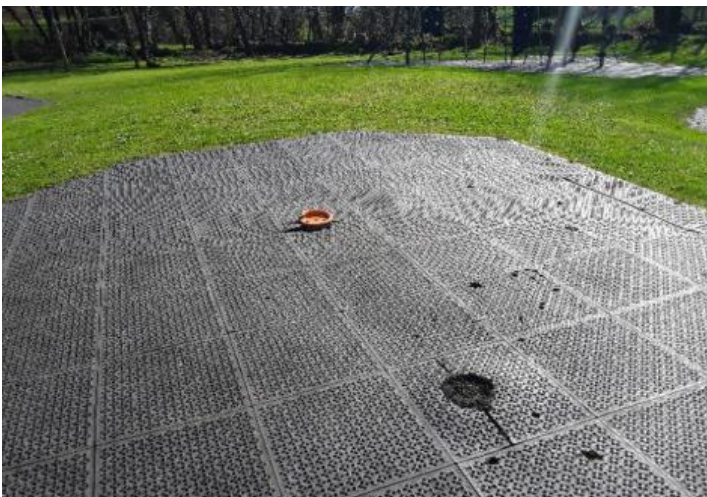
Finding: The spring donkey has been removed but the steel base is still present
Action: Replace the spring donkey or remove the foundation plates

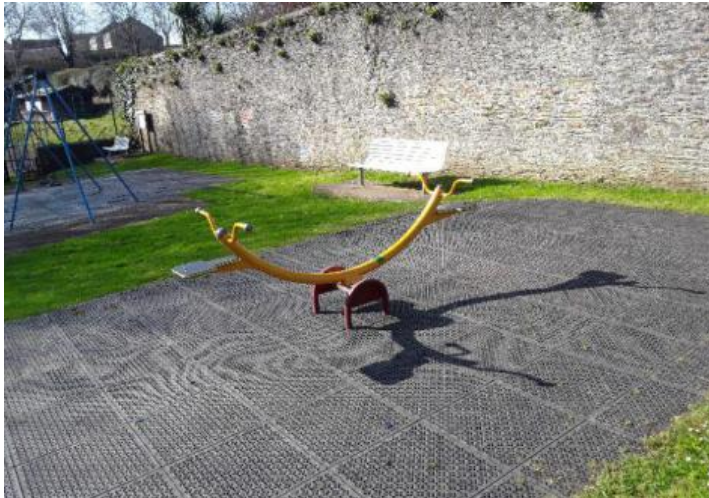
Finding: There is moderate damage to the surface

Action: Repair the damaged areas of surfacing
